Kensington Mine 2017 Environmental Audit

Coeur Alaska, Inc.

Juneau, Alaska

January 19, 2018

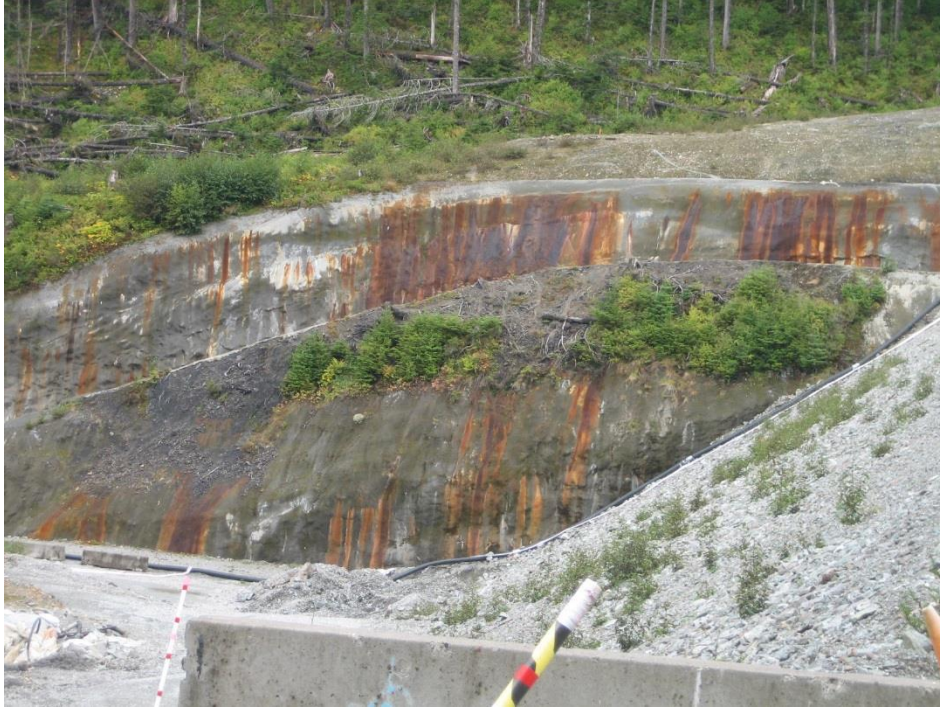
Photo Q Stage 2 Interim Spillway west wall and west abutment wall below spillway and downstream of Stage 2 Dam toe, shotcrete spillway walls with ARD seepage staining on spillway & abutment walls, looking west.

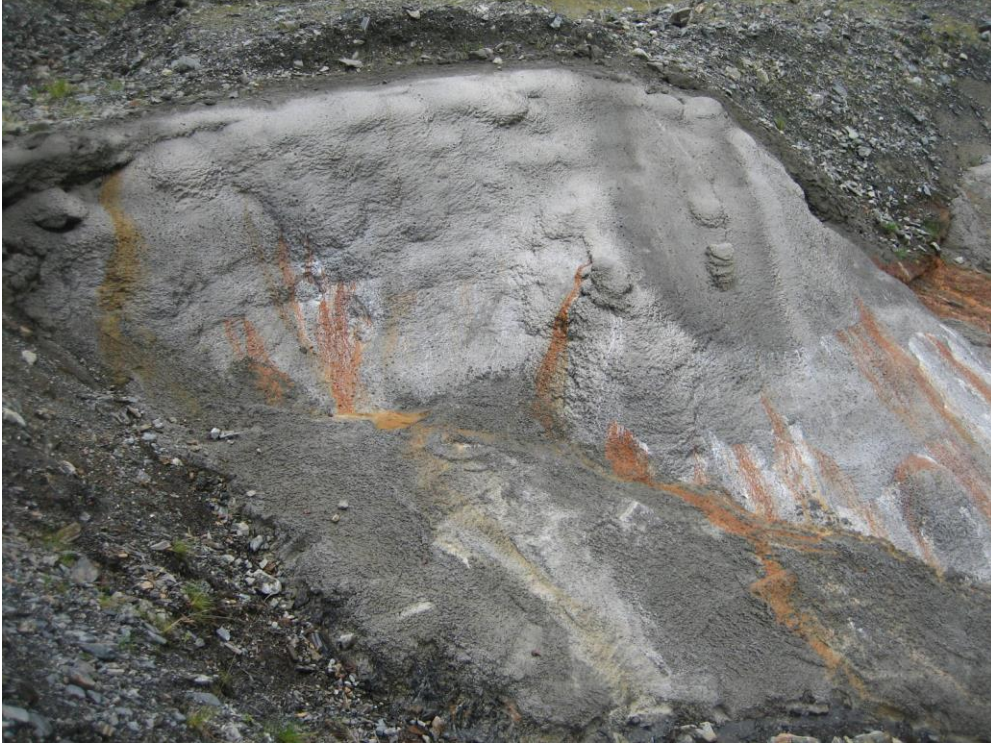
The observed condition by the Audit Team of the temporary graphitic phyllite cover on the eastern side of the downstream end of the dam is inadequate to ensure seepage and runoff does not escape containment (WMP Section 1.3.3). The Audit Team's recommendation is to add a crushed diorite cover to the exposed graphitic phyllite surfaces or a similar alternative because the shotcrete/dental concrete application does not appear to function as needed to contain seepage.

Photo T Lower Slate Lake Dam area downstream of east (left) abutment, shotcreted slopes (understood to have been excavated to rock) with staining from ARD seepage and collected seepage at toe of slope.

would be a release from containment. It is the Audit Team's recommendation that while surface water seepage from this east side of the dam abutment is potentially reporting to the dam seepage sump, that the dam seepage sump water goes to the GPPTP rather than back to the TTF.

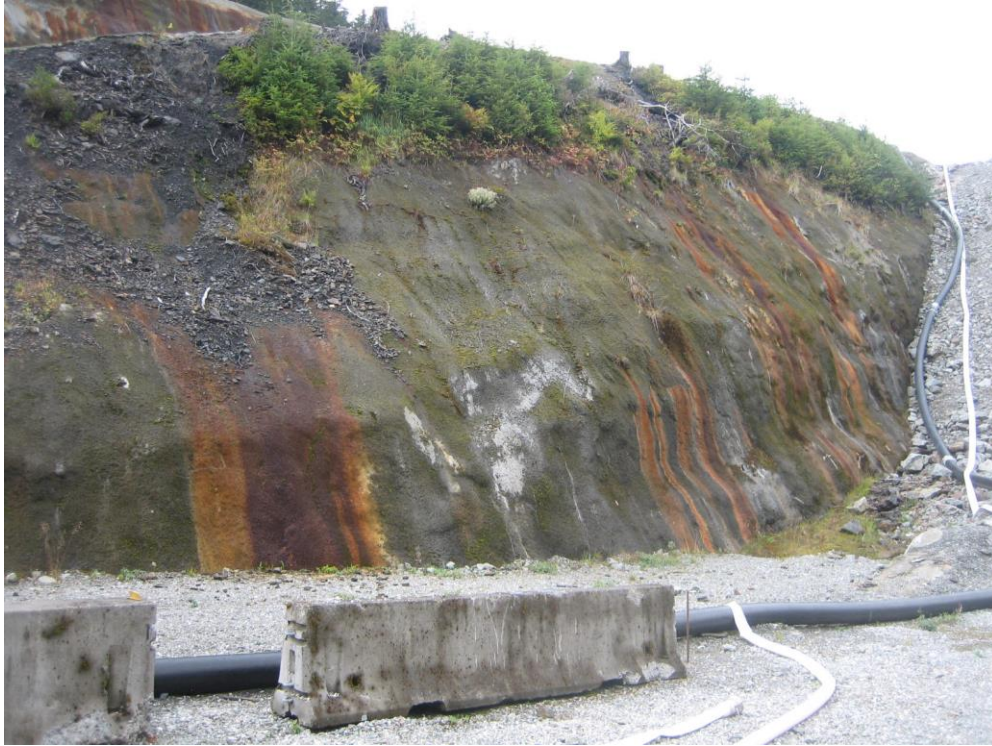
Photo CC Lower Slate Lake Dam Seepage Collection Sump return pipeline along west groin of dam. Shotcreted west abutment wall with staining from ARD seepage.

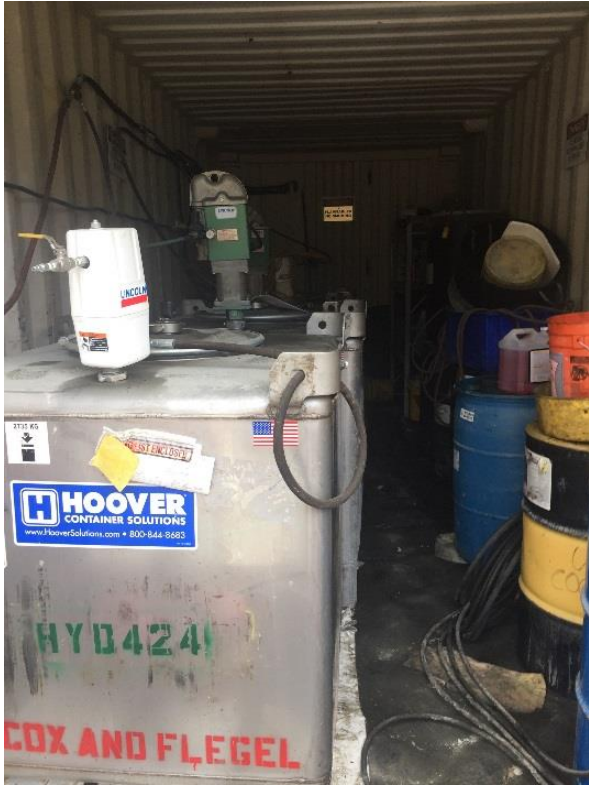
Photo PP Showing a Lube Cube (left)

- 3 drums located at the helipad connex were noted as being out of containment
- MB 9 lube cube storage connex and MB1 transmission fluid storage connex were noted as not having secondary containment, roof was noted as leaking. The inspection report noted that no petroleum products were in the tanks.
