UNITED STATES AIR FORCE
AIRCRAFT ACCIDENT INVESTIGATION
BOARD REPORT

C-17A, T/N 00-0173

3RD WING

DATE OF ACCIDENT: 28 JULY 2010

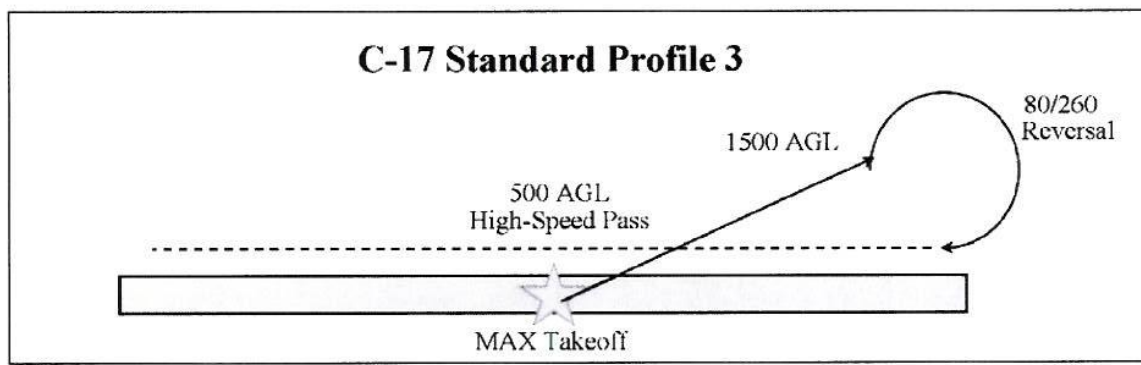
Profile 3 (Abbreviated)

The 500-foot AGL high-speed pass is accomplished by descending from 1,500 feet to 500 feet AGL during the 80/260-degree reversal turn. Upon reaching 500 feet, the aircraft accelerates to 250 kts, flying past the spectators at "show center" (the center of the viewing area; represented by the star in the diagram). (Tab BB-6)

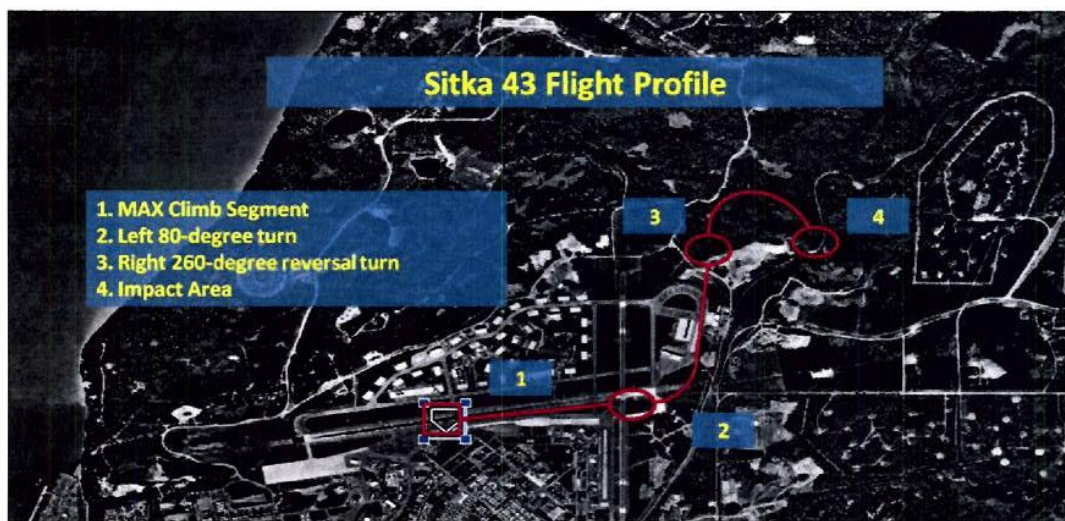
Approximately 62 seconds into the mishap sortie, the MA stalled. By this time, the deep stall protection system (the Angle of Attack Limiter System (ALS)) was active, but was overcome by the MP's rapid and aggressive maneuvers. (Tabs L-3, BB-3, CC-3 through CC-27) Within seconds, the MA's bank angle increased to a maximum of 82 degrees. The aircraft began to descend and ultimately reached a descent rate of 9,000 feet per minute, as airspeed decayed to 184 kts. (Tabs L-3, CC-3 through CC-27, CC-60 through CC-68, DD-21)

One-and-a-half seconds into the stall, several events occurred simultaneously: the MCP said "not so tight, brother"; the MSO said "watch your bank" three times; and the MP moved the control stick full left, applied left rudder, but maintained constant control stick pressure. (Tabs L-3, N-18, CC-3 through CC-27)

Five seconds prior to impact, the slats fully retracted. Approximately two seconds prior to impact, the MP was able to initiate a left roll of the aircraft, however, the roll rate was minimal due to the stall. (Tab L-3, CC-3 through CC-27) The stall protection system remained active until impact.

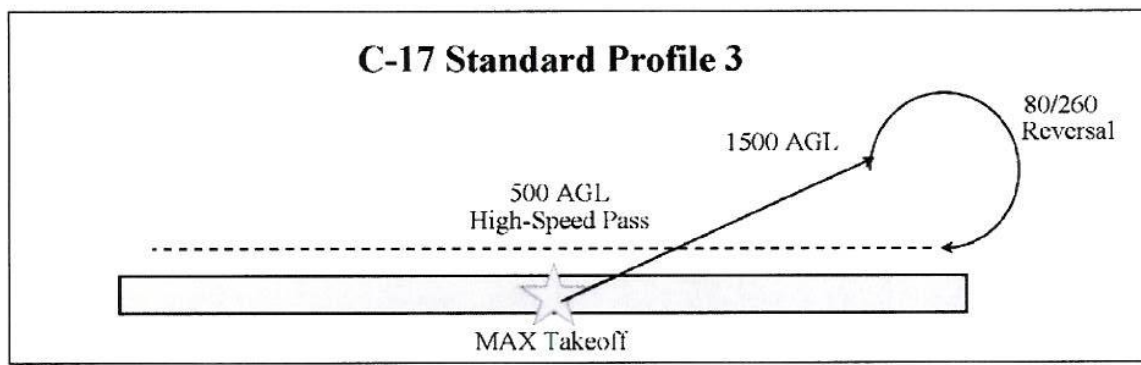
Profile 3 (Abbreviated)

The 500-foot AGL high-speed pass is accomplished by descending from 1,500 feet to 500 feet AGL during the 80/260-degree reversal turn. Upon reaching 500 feet, the aircraft accelerates to 250 kts, flying past the spectators at "show center" (the center of the viewing area; represented by the star in the diagram). (Tab BB-6)

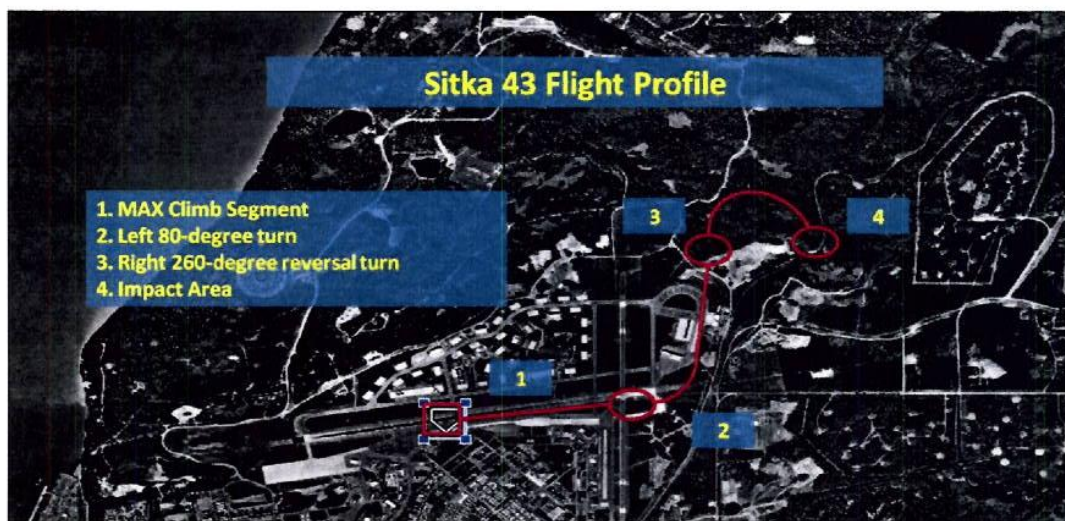
One-and-a-half seconds into the stall, several events occurred simultaneously: the MCP said "not so tight, brother"; the MSO said "watch your bank" three times; and the MP moved the control stick full left, applied left rudder, but maintained constant control stick pressure. (Tabs L-3, N-18, CC-3 through CC-27)

Five seconds prior to impact, the slats fully retracted. Approximately two seconds prior to impact, the MP was able to initiate a left roll of the aircraft, however, the roll rate was minimal due to the stall. (Tab L-3, CC-3 through CC-27) The stall protection system remained active until impact.
