Aviation Investigation Preliminary Report

Location:	Cape Yakataga, AK	Accident Number:	ANC23LA065
Date & Time:	August 27, 2023, 10:00 Local	Registration:	N6709Q
Aircraft:	Beech B36TC	Injuries:	2 Fatal
Flight Conducted Under:	Part 91: General aviation - Personal

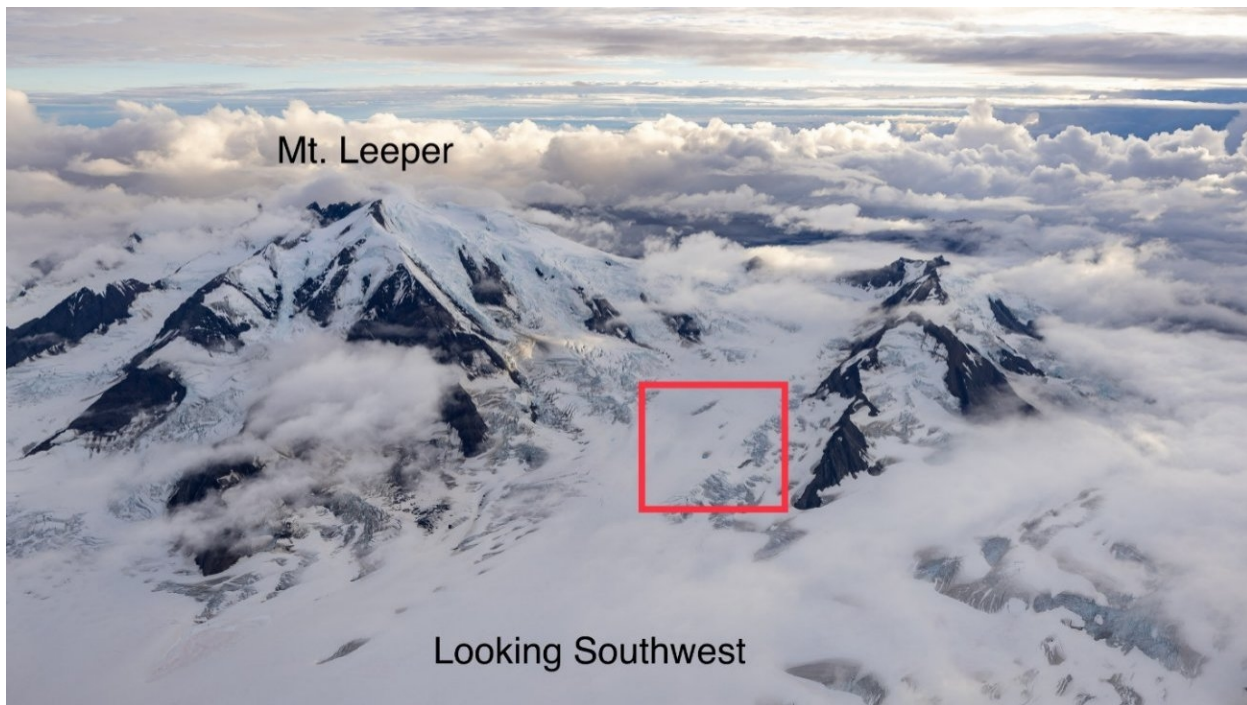
On August 28, the crew of a U.S. Coast Guard HC-130 airplane located the wreckage site near Mt. Leeper located in the Wrangell-St. Elias National Park and Preserve, at an elevation of about 4,787 ft, but terrain and continued poor weather conditions precluded reaching the site (see figure 1).

Figure 1 Aerial image of the accident site, with red box depicting area of accident site. (Alaska Rescue Coordination Center Photo)

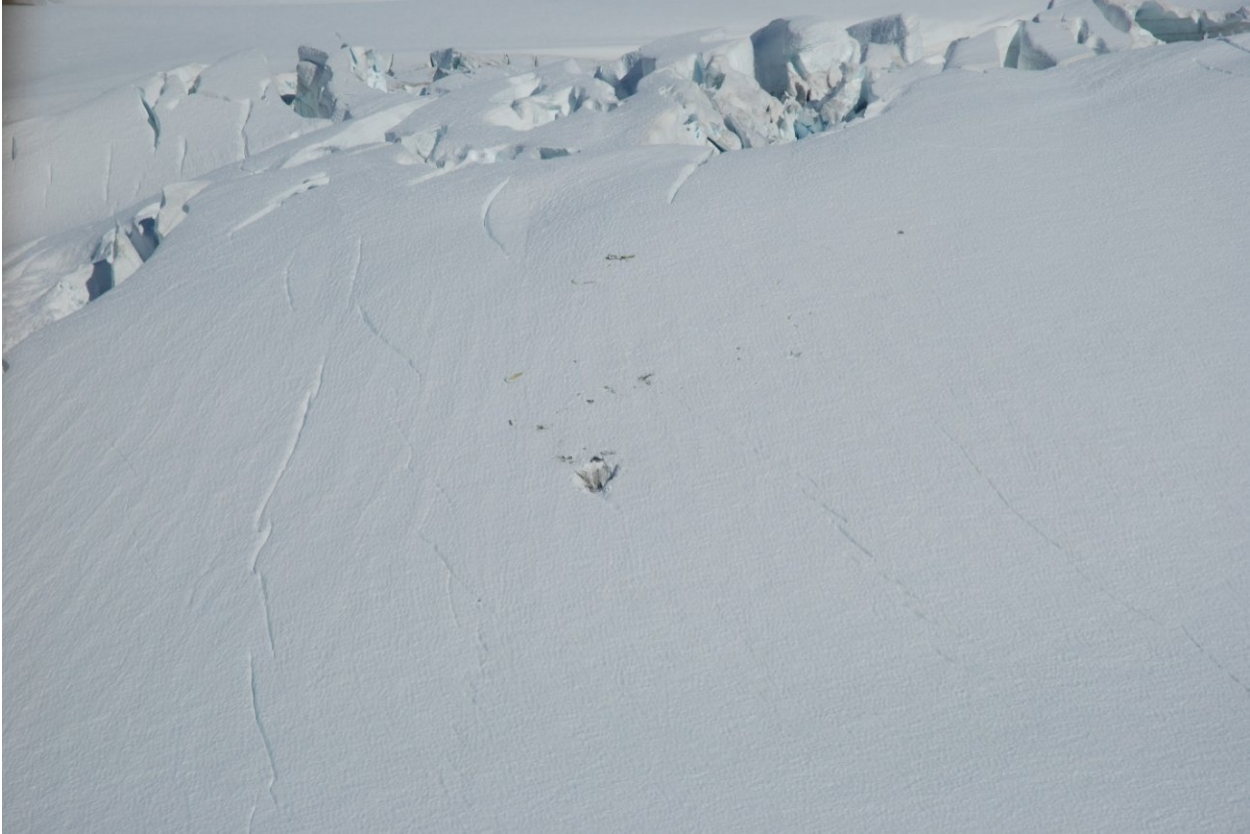
On September 5, weather conditions improved briefly, and a National Park Service (NPS) ranger was able to fly over and photograph the accident site. The fragmented airplane wreckage came to rest in a highly crevassed area on the Yahtse Glacier that continually accumulates snow (see figure 2). A sizable portion of the airplane wreckage was found in a large snow crater on the snow and ice-covered glacial terrain, with smaller portions of airplane wreckage observed adjacent to the crater.

Figure 2 Aerial view of the accident site (National Park Service photo)

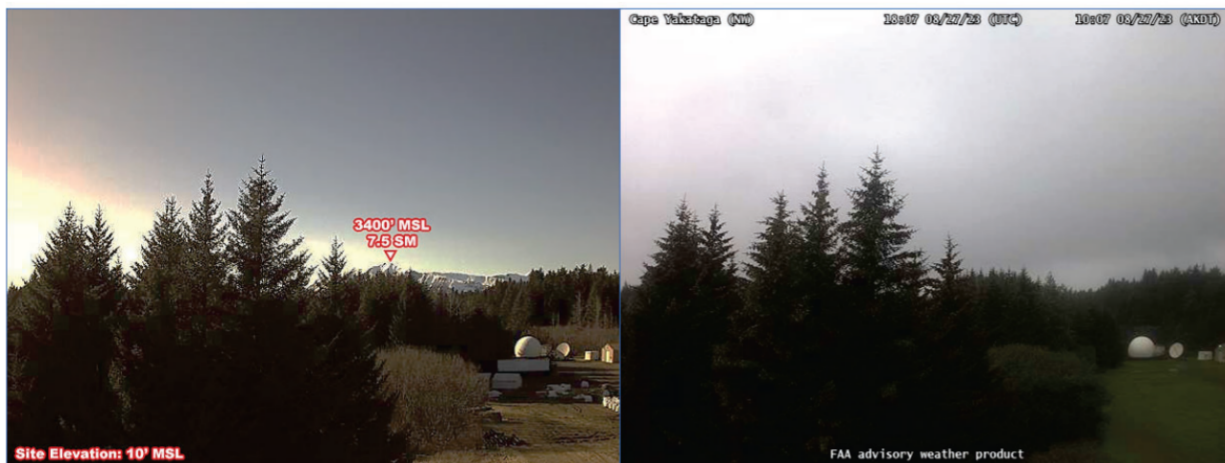
Cape Yakatage (CYT) Northwest camera view (310°) on clear day (left) and at 1807Z on August 27, 2023 (right)

There were no airports that issued official Aviation Routine Weather Reports (METARs) within 100 miles of the accident site. An FAA weather camera was located about 18 miles southwest of the accident site at Yakataga Airport (0AA1), Yakataga, Alaska. The northwest and east weather camera images were documented to define the sky conditions near the time of the accident (see figure 3). No cameras faced the direction of the accident location. The FAA weather camera imagery surrounding the period depicted low nimbostratus type clouds which obscured the higher terrain immediately surrounding the area, with visibility less than 3 miles.

Figure 3 Weather camera images depicting the clouds near the time of the accident.
