## **January 2024, Kensington Mine Tailings Line Spill**

### **Executive Summary**

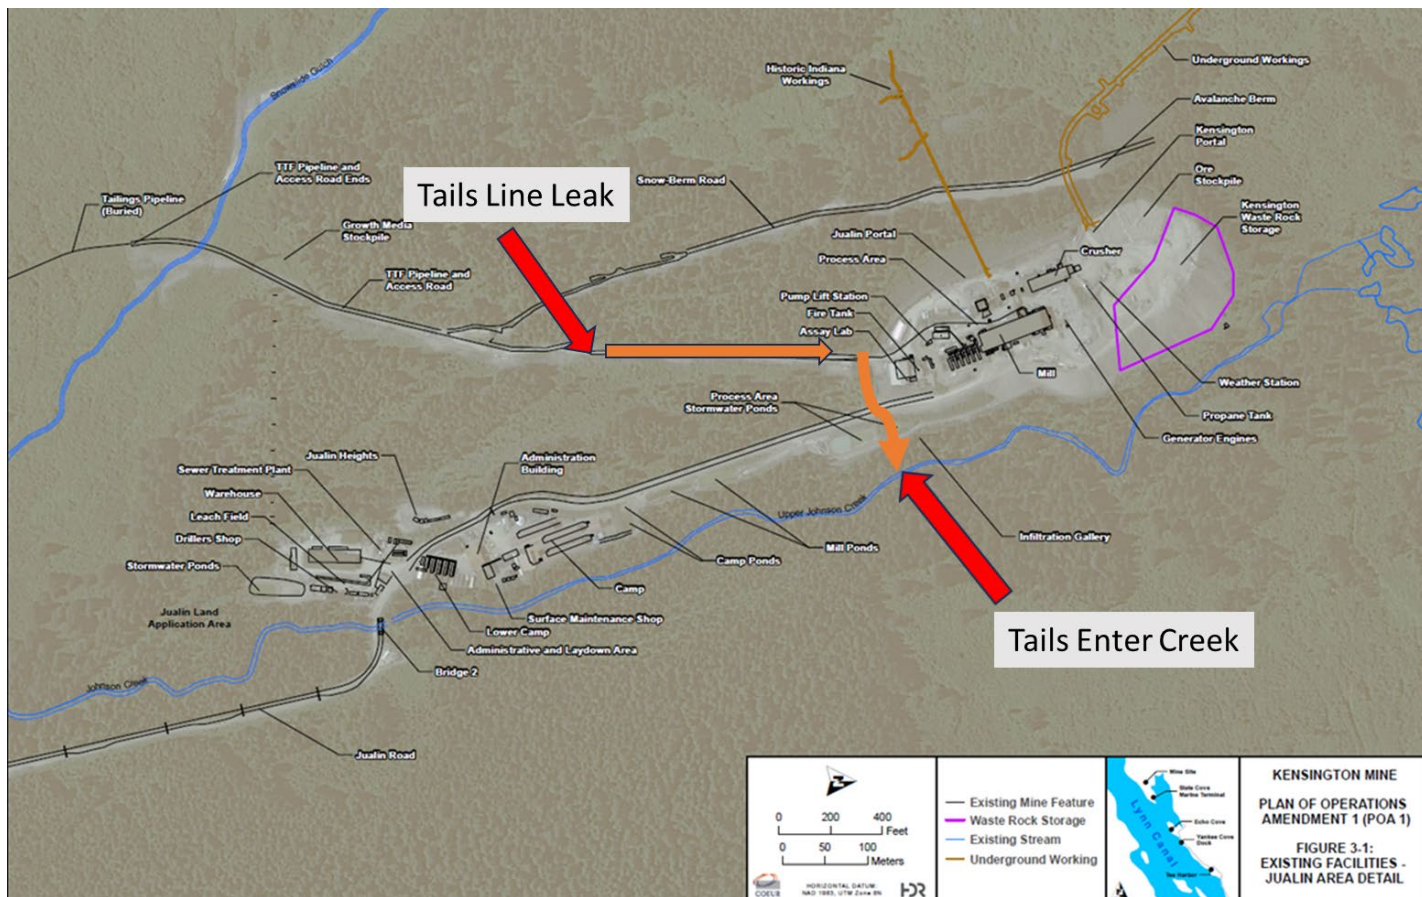
**Figure 3. Flow Path of Tailings.**

At approximately 3:00 pm the tailings pipeline leak was discovered on Pipeline Road south of the Assay Lab. Tailings were found flowing underneath a deep layer of snow and ice continuing into the freshwater drainage alongside Pipeline Road which flows into Johnson Creek (see photos 1, 2 & 3). See Figure 3 for a map of the area where the spill occurred and the flow path towards Johnson Creek. See Figure 4 for a graphical representation of tailings flow and line pressure over time.

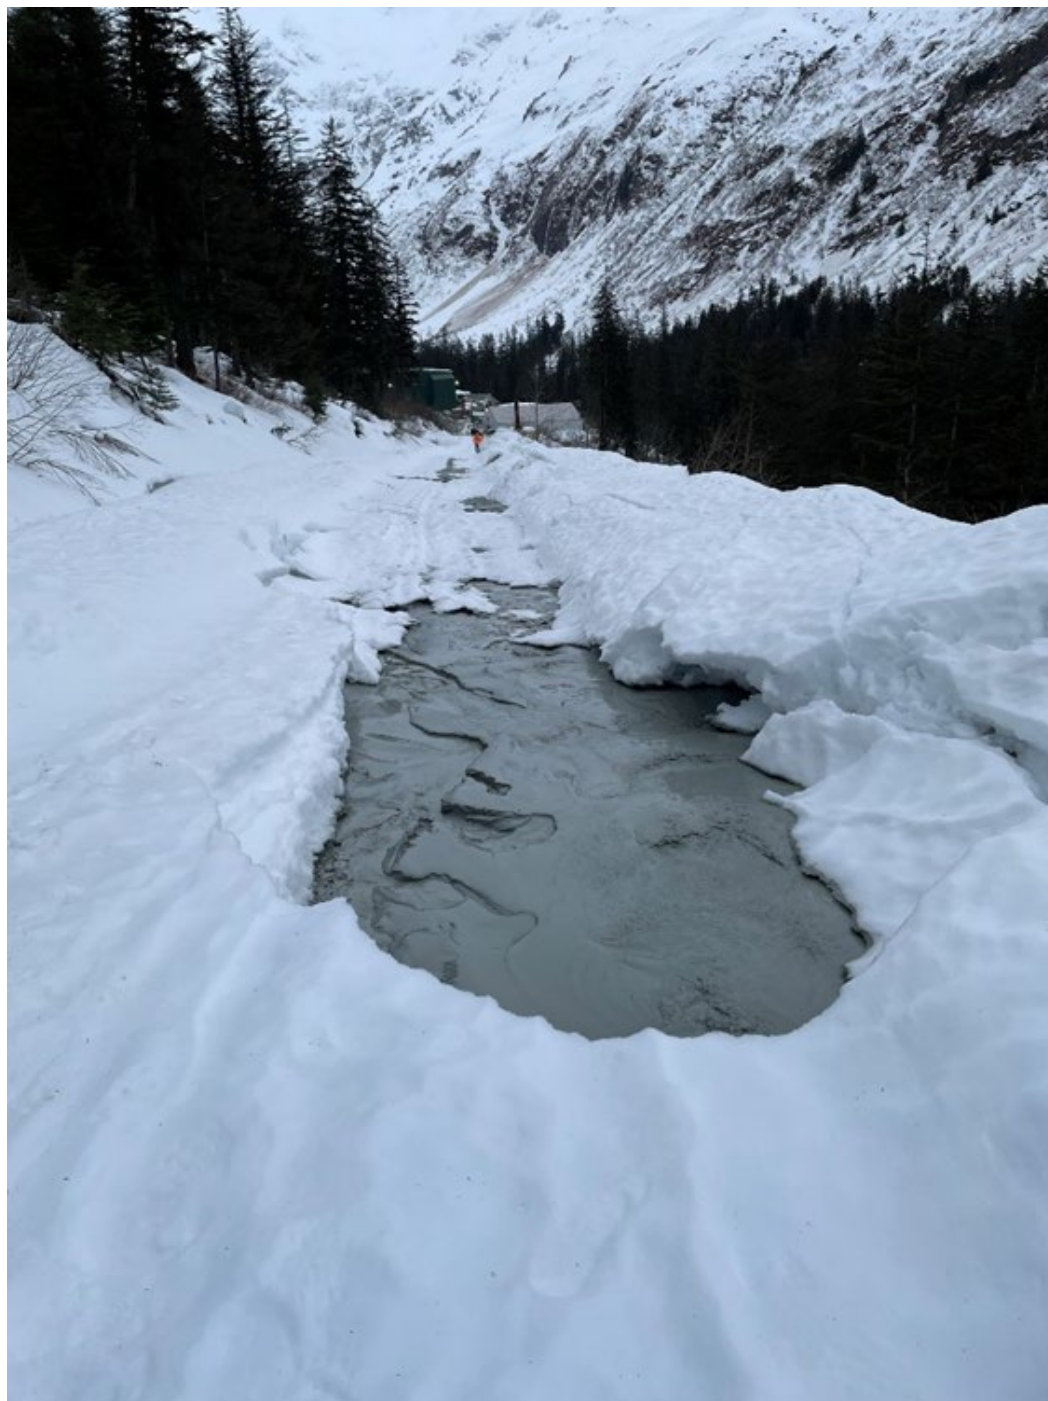
**Photo 1: Tailings leak from buried tailings line on Pipeline Rd.**

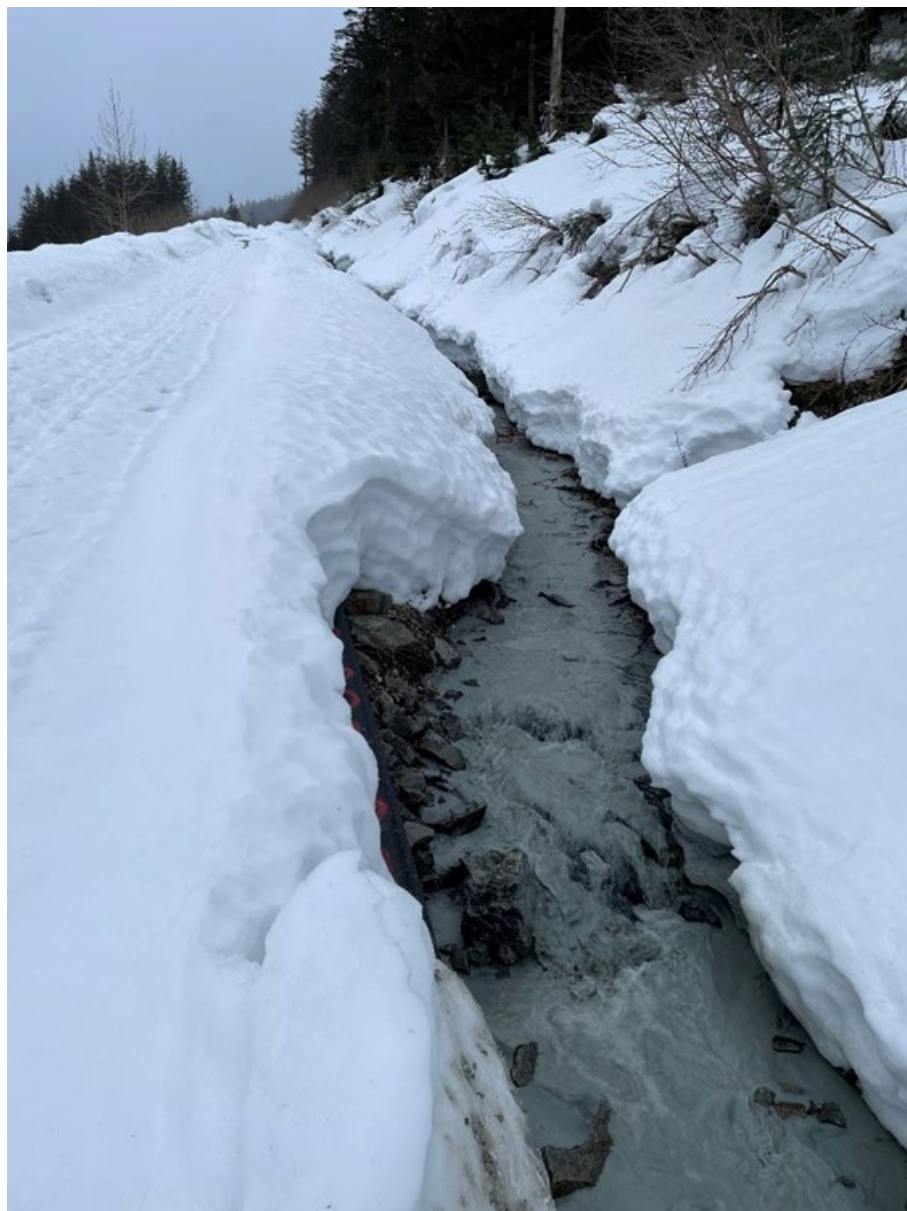
**Photo 2: Tailings in freshwater drainage along Pipeline Road leading to Johnson Creek.**

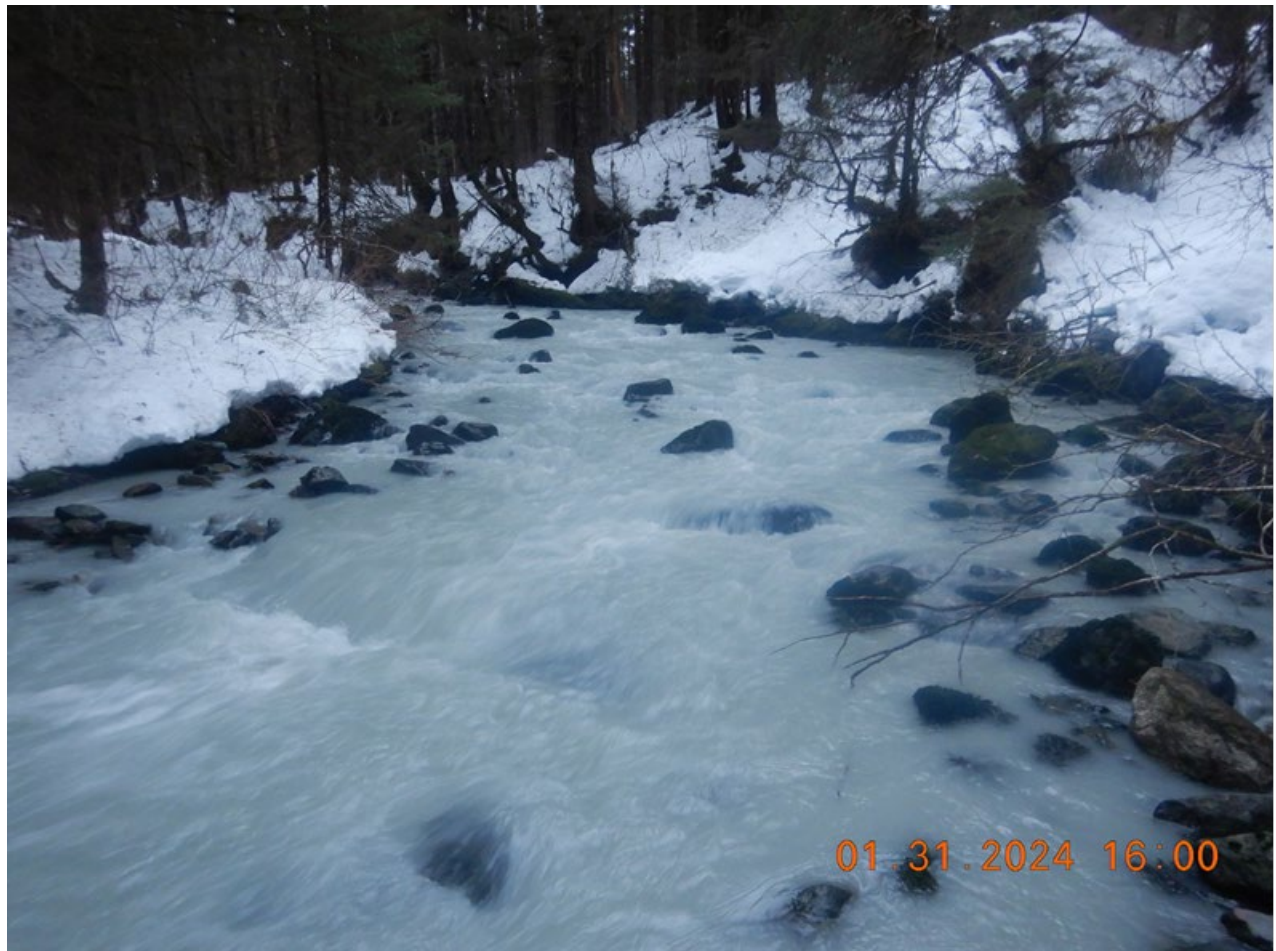
Photo 3: Johnson Creek during tailings spill.

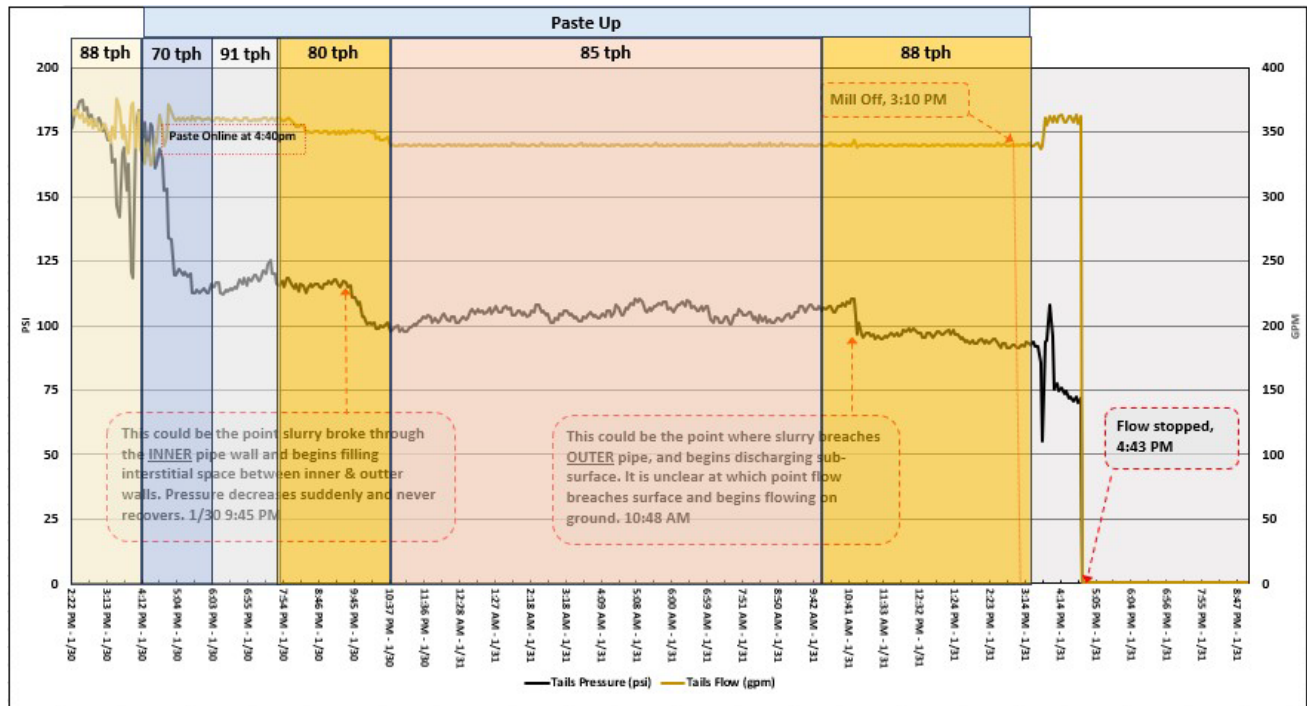
**Figure 4. Tailings line pressure and flow on the day of the incident:**

Coming out of the process change, the tails line pressure is unusually low. These pressures are possible with a normal line, but only under extremely low % solids. To be conservative, the leak time was estimated to start after 5 pm on January 30<sup>th</sup>. The mill shut down before 5pm on January 31<sup>st</sup> after the leak was detected.

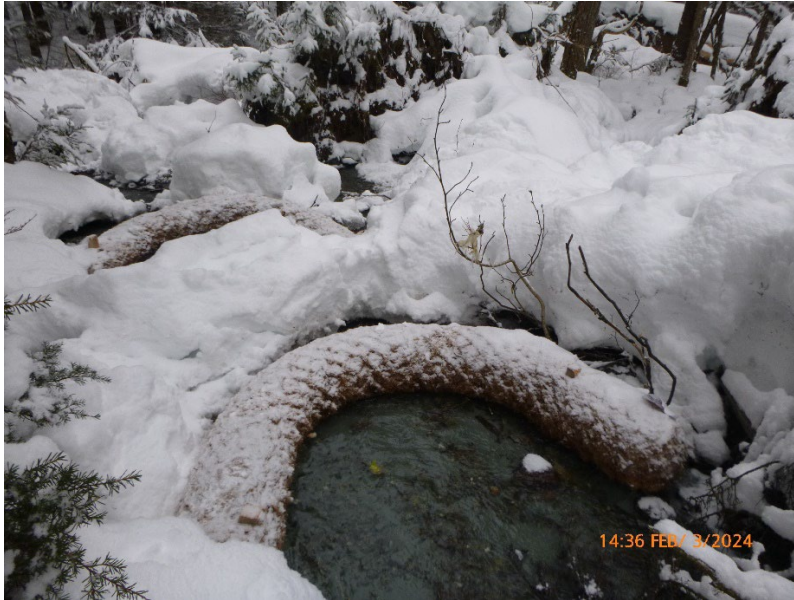
**Photo 4. Straw wattles capturing residual tailings.**

Immediately after the leak's discovery, straw wattles were placed in the freshwater drainage next to Pipeline Road and in the riparian area of Johnson Creek to capture any residual tailings and prevent migration to the creek (Photo 4). Following the placement of wattles heavy equipment was deployed to the scene. The equipment was used to remove tailings from the Pipeline Road. Also, the freshwater drainage next to Pipeline Road was diverted to prevent residual tailings from reaching Johnson Creek.

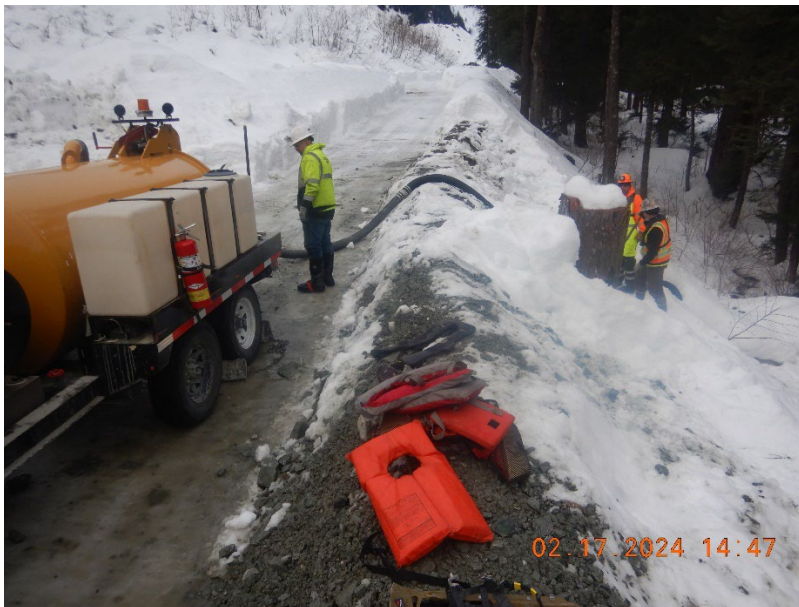
**Photo 5. Vacuum trailer removing tailings near Johnson Creek.**

A vacuum trailer was used to remove residual pockets of tailings from the freshwater drainage leading to Johnson Creek (Photo 5). An in-stream cleanup of the tailings was conducted to remove tailings from Johnson Creek (Photo 6). All recovered tailings were either disposed of underground or in the TTF, both

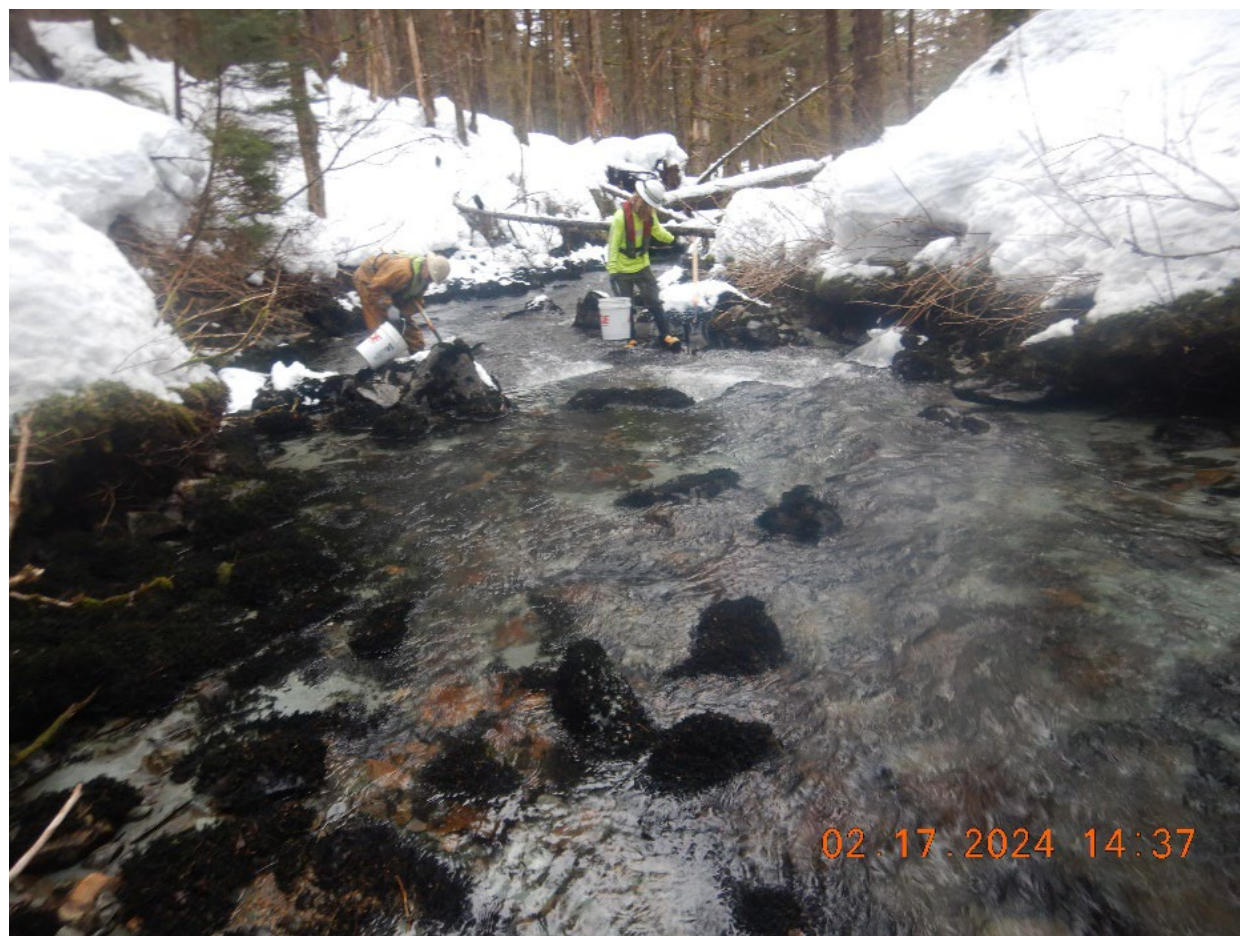
**Photo 6. Mine personnel removing tailings from Johnson Creek.**

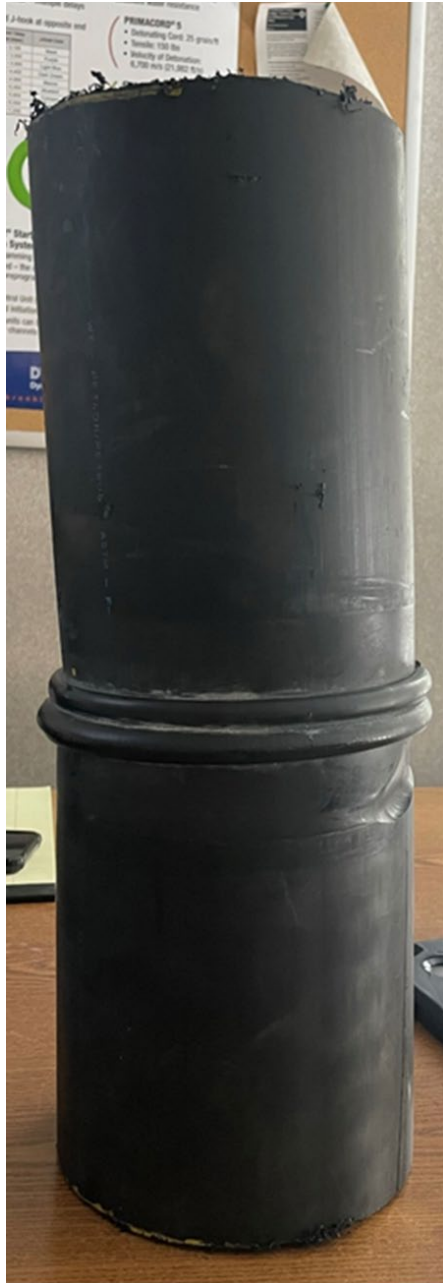
The hole in the pipeline occurred at a joint where two sections of the pipe are joined by an Electrofusion weld. The leak likely started as a pinhole and increased over time due to the abrasive nature of the tailings and the high-pressure environment within the inner pipe. Once the inner pipe was breached a second hole in the outer pipe formed due to the high-pressure jet exiting the inner pipe.

The section of the pipeline where the hole is located was excavated and the damaged portion of the pipeline was cut and removed. The removal of the damaged section allowed for further investigation. At the junction of the two sections of pipe it was found that the two pipes were slightly misaligned when they were Electrofused. Misalignment of this section during original pipeline installation would cause a weaker weld joint, see Photo 6. At this weld joint a lip formed in the inner pipe, this lip would create an area of turbulence at the weld and would promote a wear channel in the pipe. Over time the tailings would wear through the inner pipe and cause a pinhole to form, then a larger hole would propagate over time. Photo 7 shows the hole in the inner pipe and Photo 8 shows the corresponding hole in the outer pipe.

**Photo 6. Misaligned Electrofusion weld at failure point.**

Below is a list of corrective actions to be taken to prevent future tailings line failures.

1. A full internal pipeline inspection will be conducted using non-destructive methods such as cameras or pigs. A specialist is needed to assist with the assessment. A pipeline pigging specialist is scheduled for a site visit on April 8-9.

2. Once an internal pipeline inspection process has been established, internal inspections will be routinely conducted.
3. Add a pressure indicator alarm for the outer 10-inch line which would enable detection of a leak within the inner 6-inch line.

4. A tailings flow meter will be installed near the end of the tailings line at the TTF. This will enable monitoring of flow near the outlet of the pipeline to ensure flow rates are equal at both the inlet and outlet of the tailings line. An alarm will be installed on the outlet flow meter which will be tied to the Mill Process Control Room. This will allow operators to shut down the mill in the event a drop in flowrate is detected.

5. Establish a formalized response protocol specific to a tailings line release, this will aid a quick response and cleanup.
6. Provide training and equipment to perform certified HDPE pipeline repairs on site.

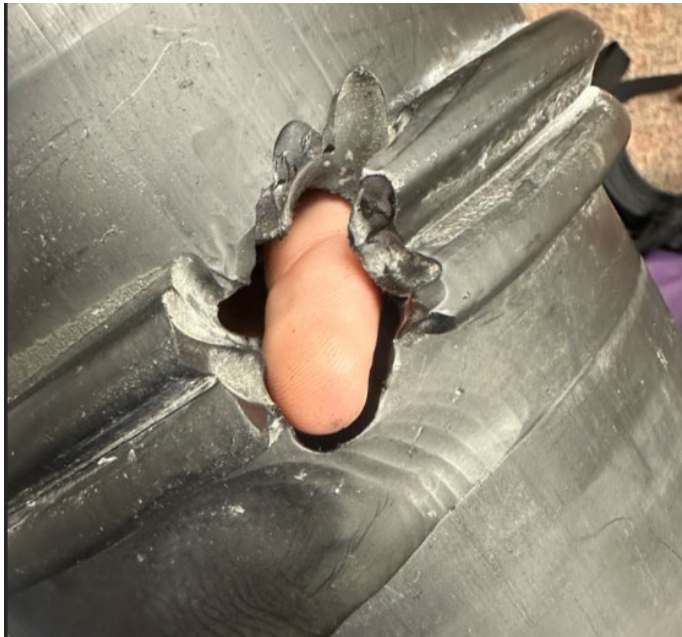
The tails pipe failed by abrasion; this suggests a pinhole failure in the inner pipe allowed a thin jet of tails slurry to exit and erode both the inner and outer walls of the pipe. There were no signs of a failure due to bursting (excessive pressure/plugged line).

**Photo 7. Inner pipe breach.**

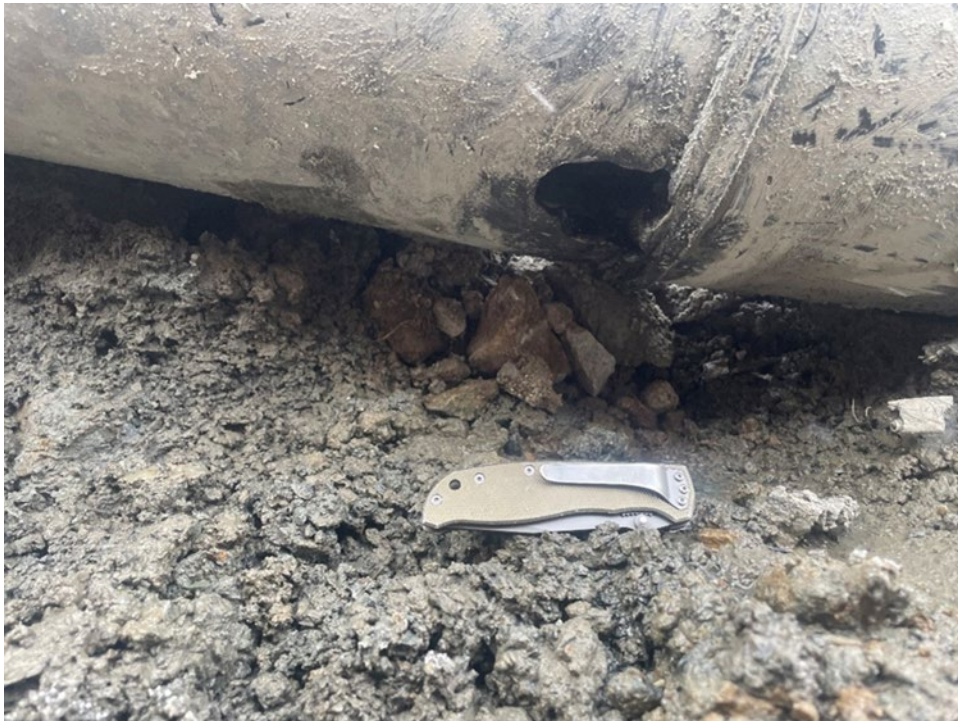
**Photo 8. Outer pipe breach.**
