**HISTORICAL EVALUATION OF THE TUGBOAT *CHALLENGER*
(JUN-01257),
JUNEAU, ALASKA**

November 2015

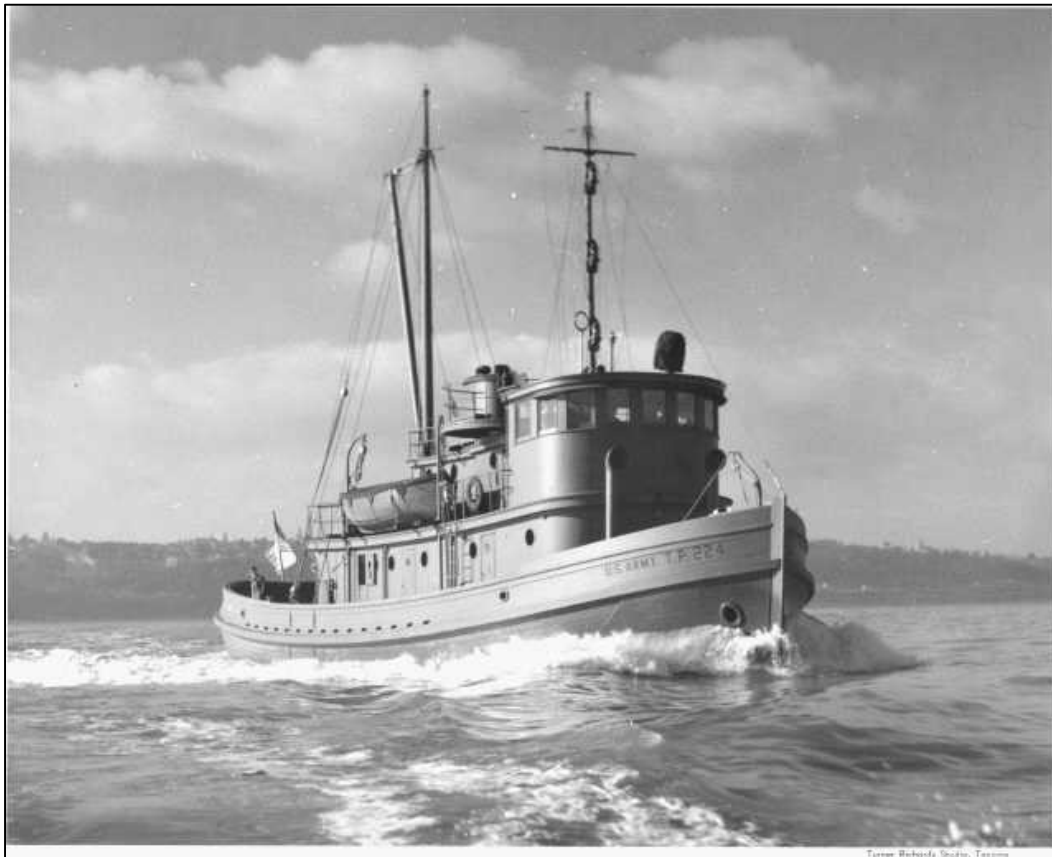
Figure 2. A TP-class harbor tug (TP 224), as delivered from the shipyard in 1943 (photograph – Tacoma Public Library).

As built, US. Army TP 126 was 96 feet (ft.) in length, with a listed breadth of 24.8 ft. and depth of 8.5 ft. She had a listed gross tonnage of 134, and a net tonnage of 107. The nearly vertical stem, rounded pilothouse, and extended deckhouse are typical for harbor tugs of this period. While no photos of TP 126 dating to this time could be located, an identical vessel of the same class (TP 224, built by Petrich Shipyards in Tacoma, Washington) is shown in Figures 2 – 3 below.

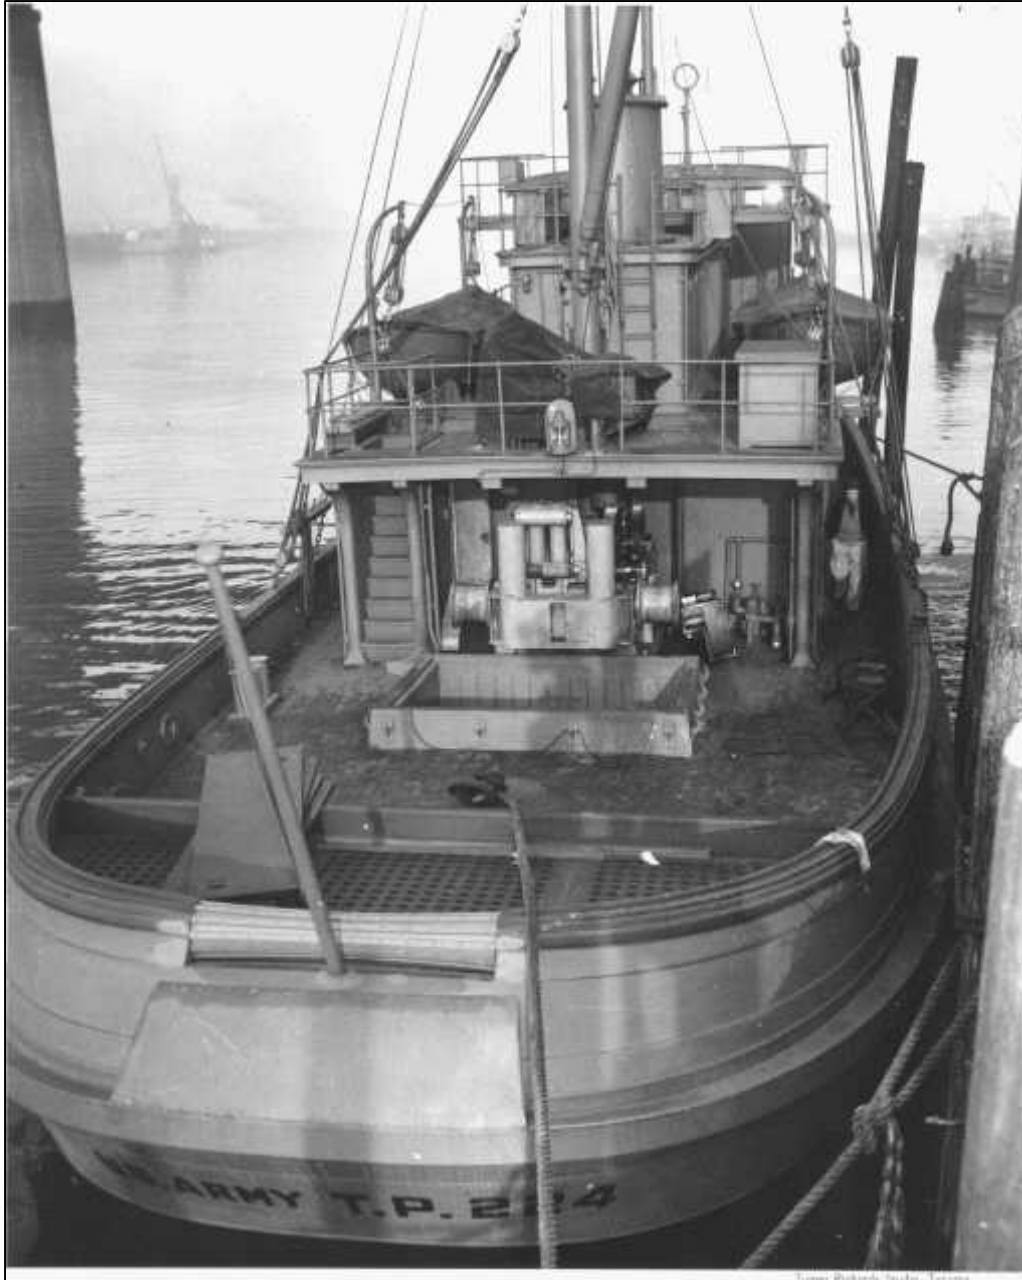
Figure 3. TP 224 at the dock, 1943. Note open working deck and tow handling equipment (photograph – Tacoma Public Library).

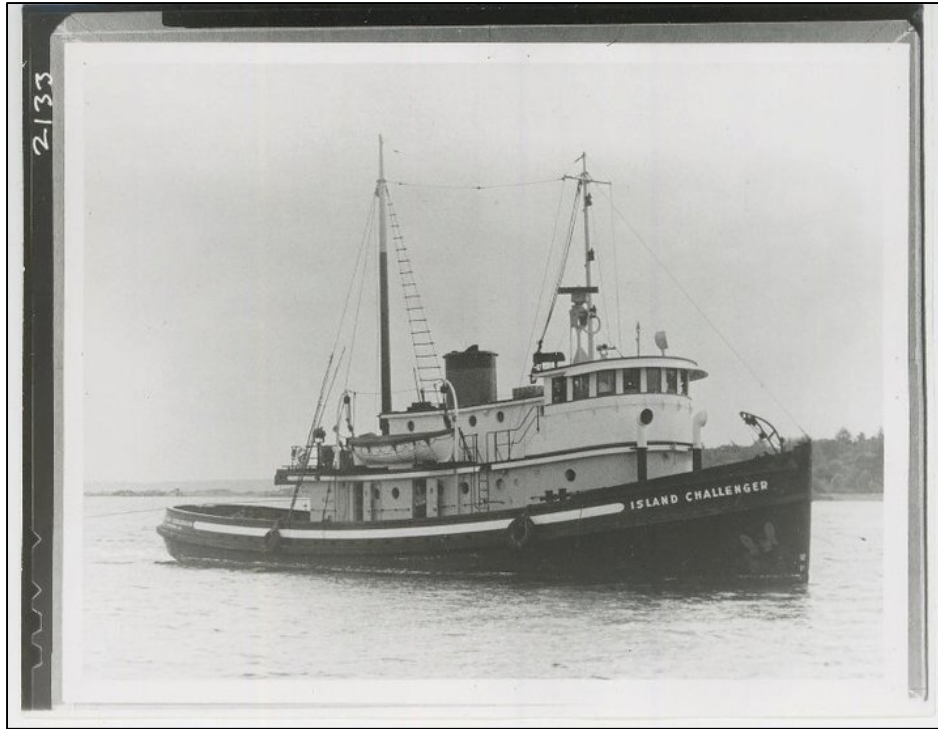
Figure 4. *Island Challenger* in original configuration, date unknown (prior to 1962) (photograph – Vancouver Maritime Museum).

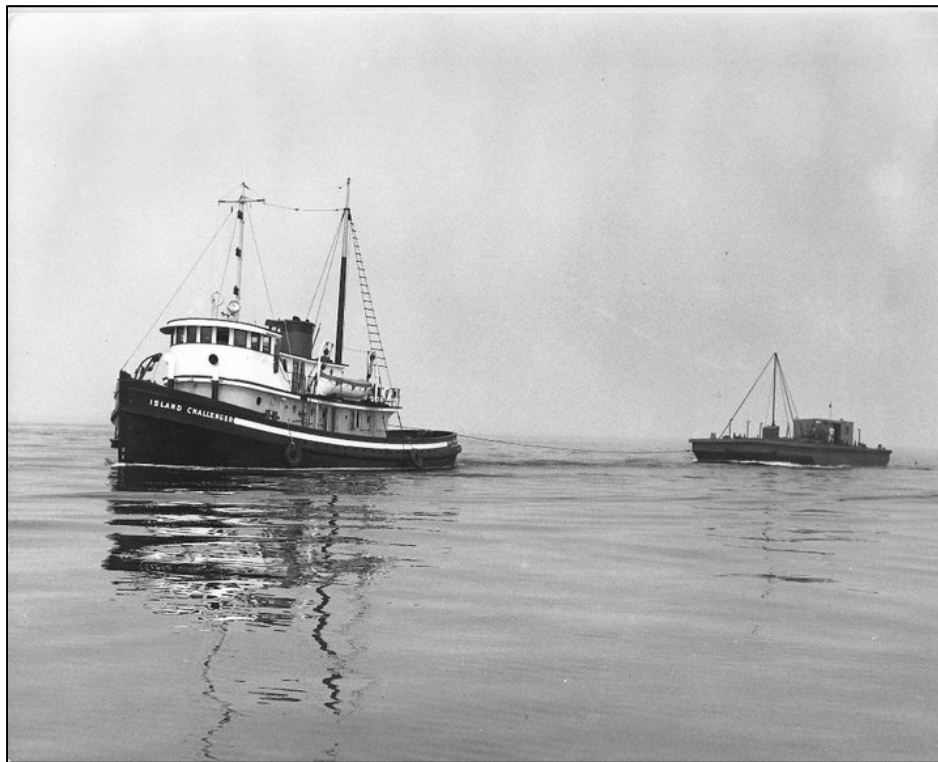
Figure 5. *Island Challenger* pulling a tow, date unknown (prior to 1962) (photograph – Vancouver Maritime Museum).

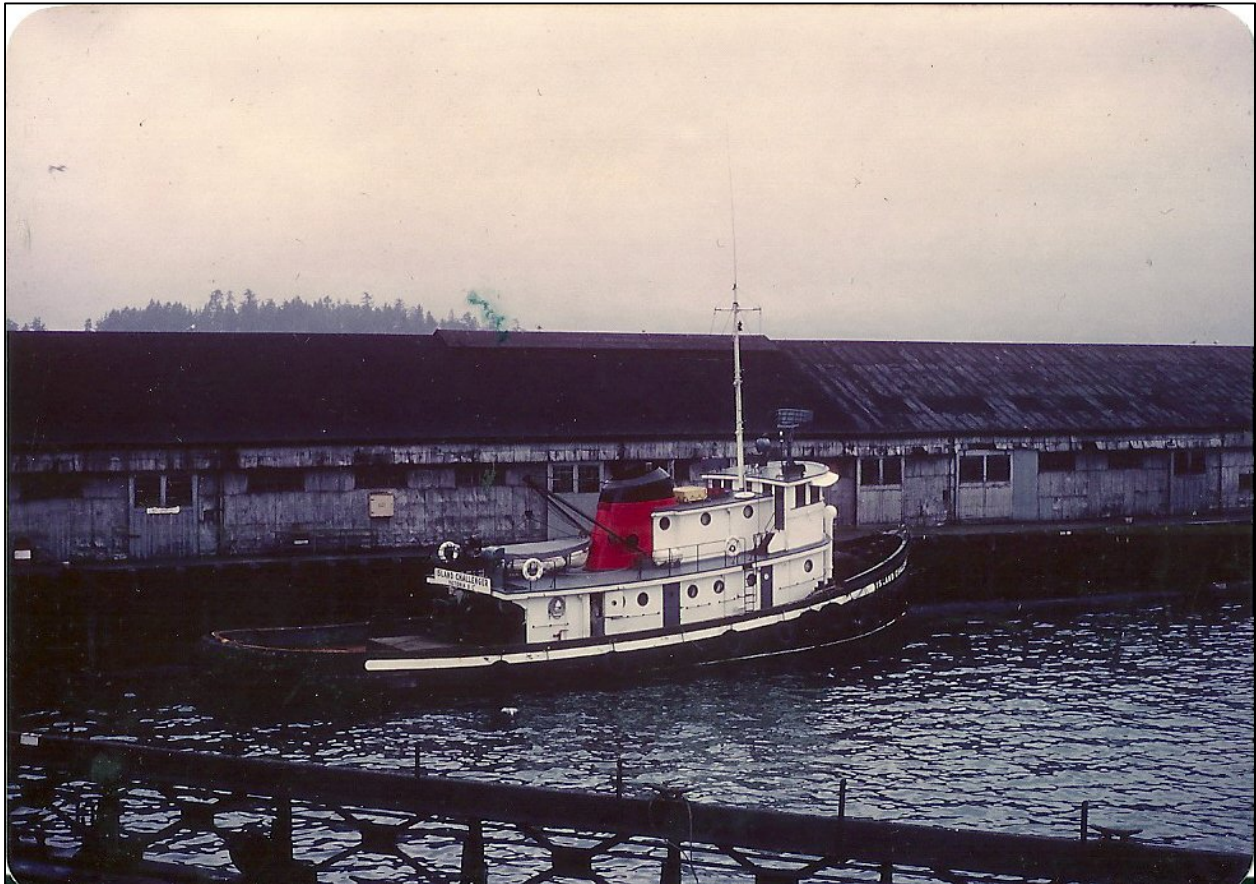
Figure 6. *Island Challenger* after engine replacement, note new exhaust stack and modified upper cabin (photograph – Vancouver Maritime Museum).

In 1962, *Island Challenger* underwent significant modifications in connection with the replacement of her main engine. The original equipment was a 450 horsepower (hp) six-cylinder Fairbanks-Morse diesel engine, which was replaced with a 1065 hp Caterpillar D398. The new engine necessitated replacement of the exhaust stack and considerable modification of the upper superstructure. About half of the upper cabin structure (everything aft of the stack) was removed, including the aft mast and boom. The two lifeboats (port and starboard on either side of the stack) were replaced with a single lifeboat or skiff, situated immediately aft of the new exhaust stack housing (Figure 6).

and extended slightly aft of midships. When the engine was replaced in 1962, the upper cabin was truncated at the new exhaust stack. The aft mast and boom were also removed at this time. The extensive renovations that were carried out to make *Challenger* suitable for guest accommodation as a “Bunk & Breakfast” further altered the vessel’s character. Most significantly, the entire open stern working deck – one of the most distinctive features of a tugboat – was entirely covered over with cabin space, and specialized equipment associated with tow handling (tow hooks and winches, bitts, capstans, etc.) was removed. These modifications significantly altered the vessel’s design and historic character. *Challenger* therefore does not retain integrity of design.

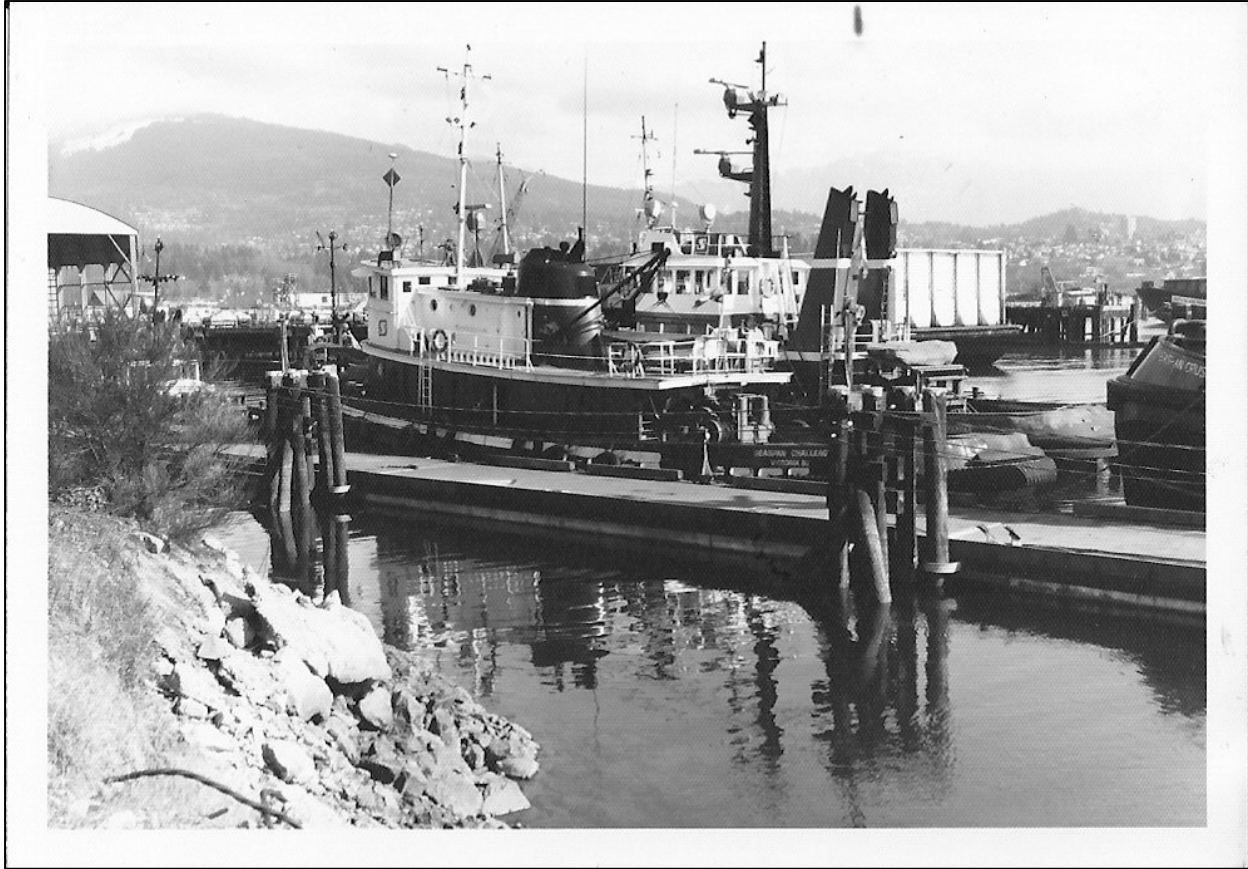
Figure 7. *Seaspan Challenger*, date unknown (prior to 1983) (photograph – Vancouver Maritime Museum).

In 1971, Island Tug and Barge merged with the Vancouver Tug Boat Company, and the resulting company was named ‘Seaspan’. Following the merger, *Island Challenger* was renamed *Seaspan Challenger* (Figure 7). In 1983 Seaspan retired the vessel, and she was sold to a private owner (Figure 8). From 1985, the vessel (now named simply *Challenger*) was moored on Lake Union in Seattle, Washington, and used as a “B&B – Bunk and Breakfast”, offering accommodation for guests and tourists.

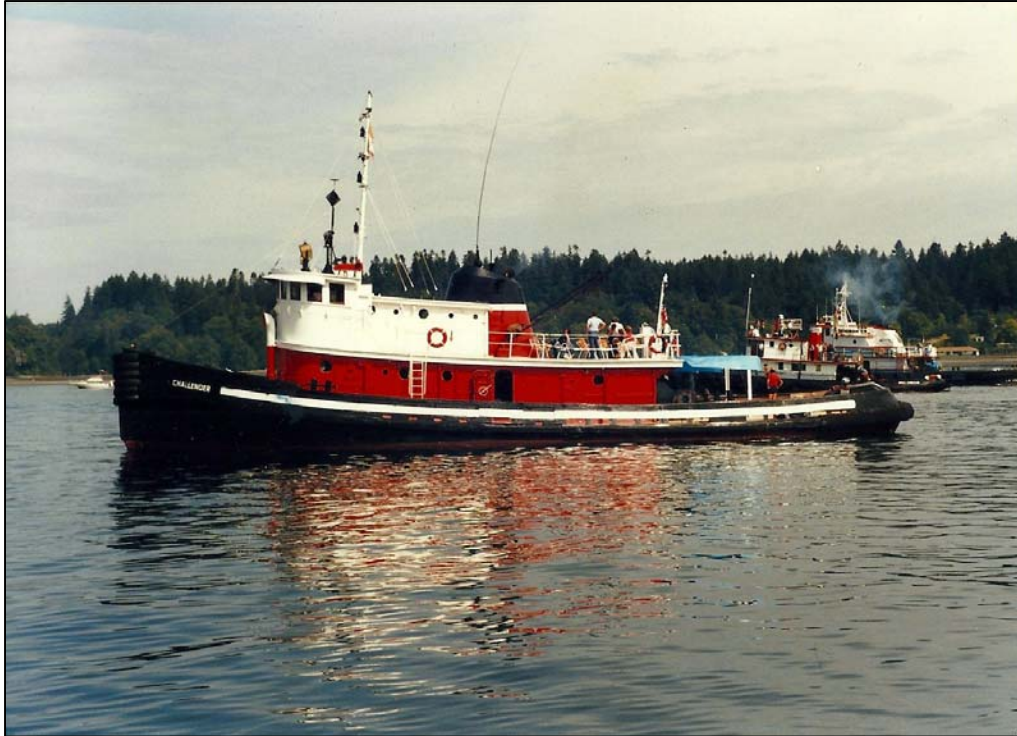
Figure 8. *Challenger* as a private vessel, before extensive modifications (photograph – Tugboat Challenger n.d.).

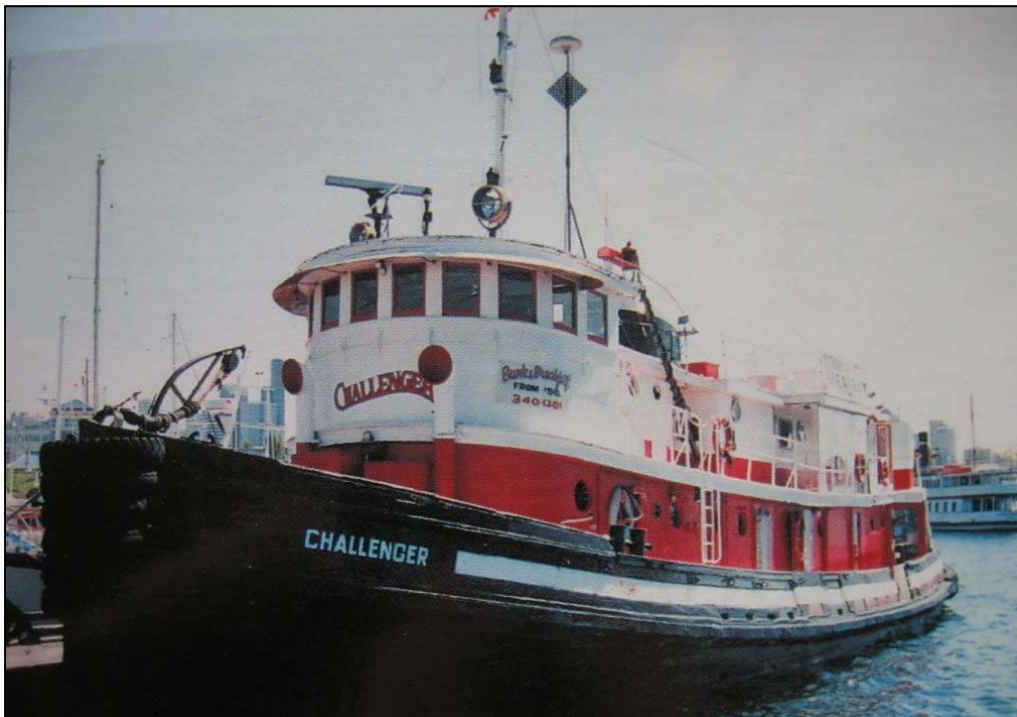
Figure 9 *Challenger* as a “Bunk & Breakfast” on Lake Union, Seattle, after 1985. Note extensive modification of deckhouse and upper cabin structure (photograph – Tugboat Challenger n.d.).

During her time as a B&B, extensive renovation took place and new structure was added. The cabin area on the main deck was extended aft nearly to the stern, completely covering the former open stern deck working area. New cabin structure was added on the pilothouse level as well, making a two-story structure all way to the vessel's stern (Figure 9). These modifications, including new staterooms and showers, provided additional facilities and space for guest accommodations.

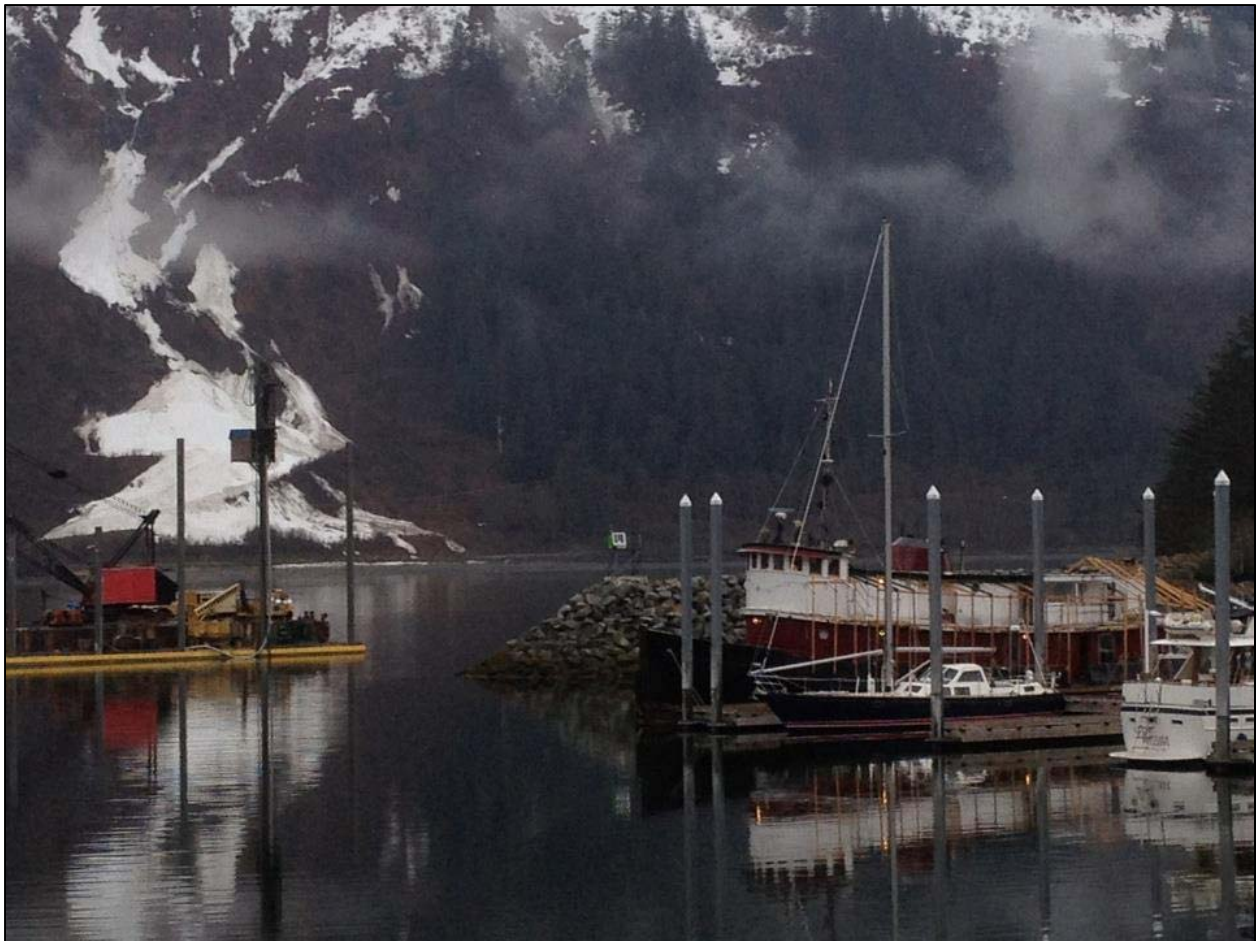
Figure 10. *Challenger* docked in Juneau, Alaska (photograph – Tugboat Challenger n.d.).

Sometime around 2002, the *Challenger* was sold and brought to Juneau, Alaska, where she was used as a live-aboard (Figure 10). Further renovation occurred, and a wooden framework was erected over the port and starboard deckways, and the remaining stern deck (Figure 11). The framework was presumably intended to be covered in canvas or plastic sheeting, providing a weather-proof work area, under which to continue renovation to the decaying pilothouse and cabin structures.

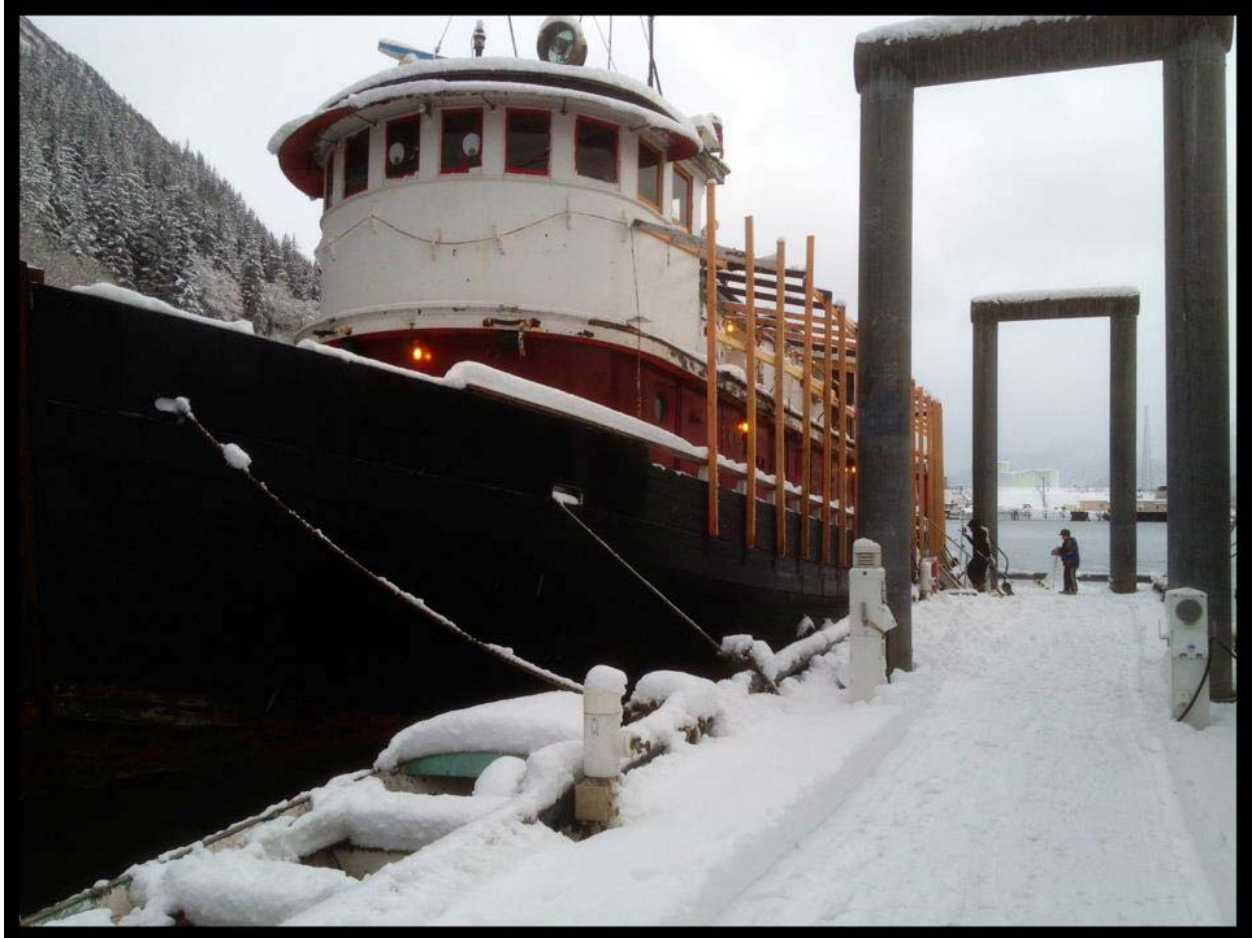
Figure 11. *Challenger* at the dock in Juneau. Note framework erected to cover portside walkway (photograph – Tugboat Challenger n.d.).
