UNITED STATES AIR FORCE
AIRCRAFT ACCIDENT INVESTIGATION
BOARD REPORT

C-17A, T/N 00-0173

3RD WING

DATE OF ACCIDENT: 28 JULY 2010

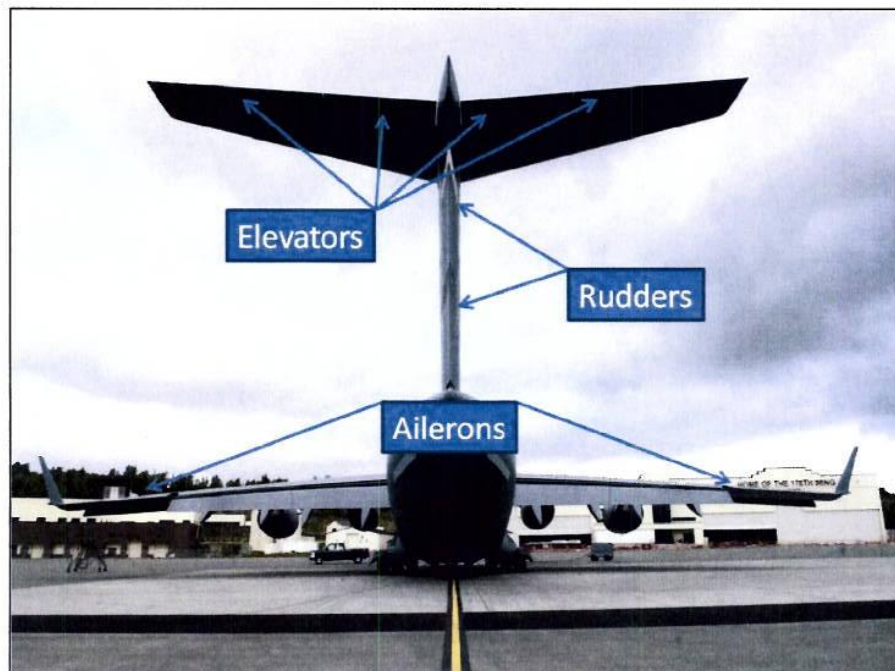
Primary Flight Controls

Portions of the right aileron surface and actuator, both rudder surfaces, and all four elevator surfaces were recovered. The AIB maintenance advisors inspected all surfaces and verified the integrity of the actuators and actuator/surface attachment points. Various pictures of the actuators and attachment points are attached in this report. (Tab Z-4 through Z-9) There was no indication of structural or mechanical failure in any areas reviewed. (Tab EE-3)
