## **January 2024, Kensington Mine Tailings Line Spill**

### **Executive Summary**

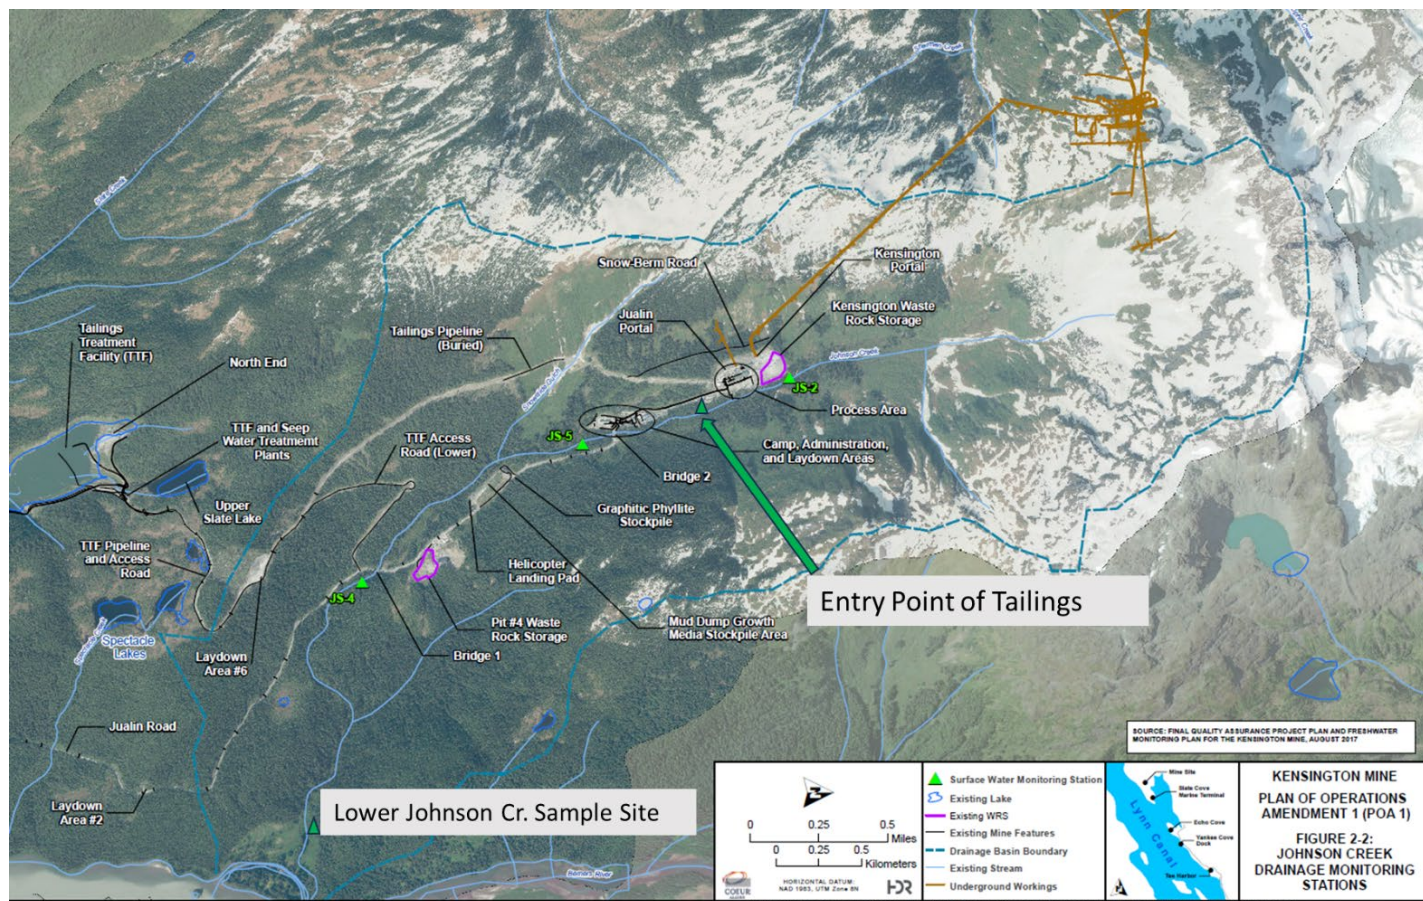
**Figure 5. Johnson Creek water quality sample locations, indicated in green.**

The day after the incident, February 1<sup>st</sup>, additional water quality sampling was conducted. The February 1<sup>st</sup> water quality sample results are presented in Table 2, all results are within Alaska Water Quality Standards. To further assess water quality, sampling was again conducted at all APDES permit receiving water sample sites one week later, on February 6<sup>th</sup>. The February 6<sup>th</sup> results are presented in Table 3. No exceedances of water quality standards occurred on February 6<sup>th</sup>. See Figure 5 for a map detailing the water quality sampling locations.

The presence of tailings in Johnson Creek was also investigated during the water quality sampling events. No tailings in Johnson Creek were found beyond sample site JS5, upstream of the creek's anadromous reaches. Note that the tailings are geochemically inert and are non-acid generating and do not leach metals.

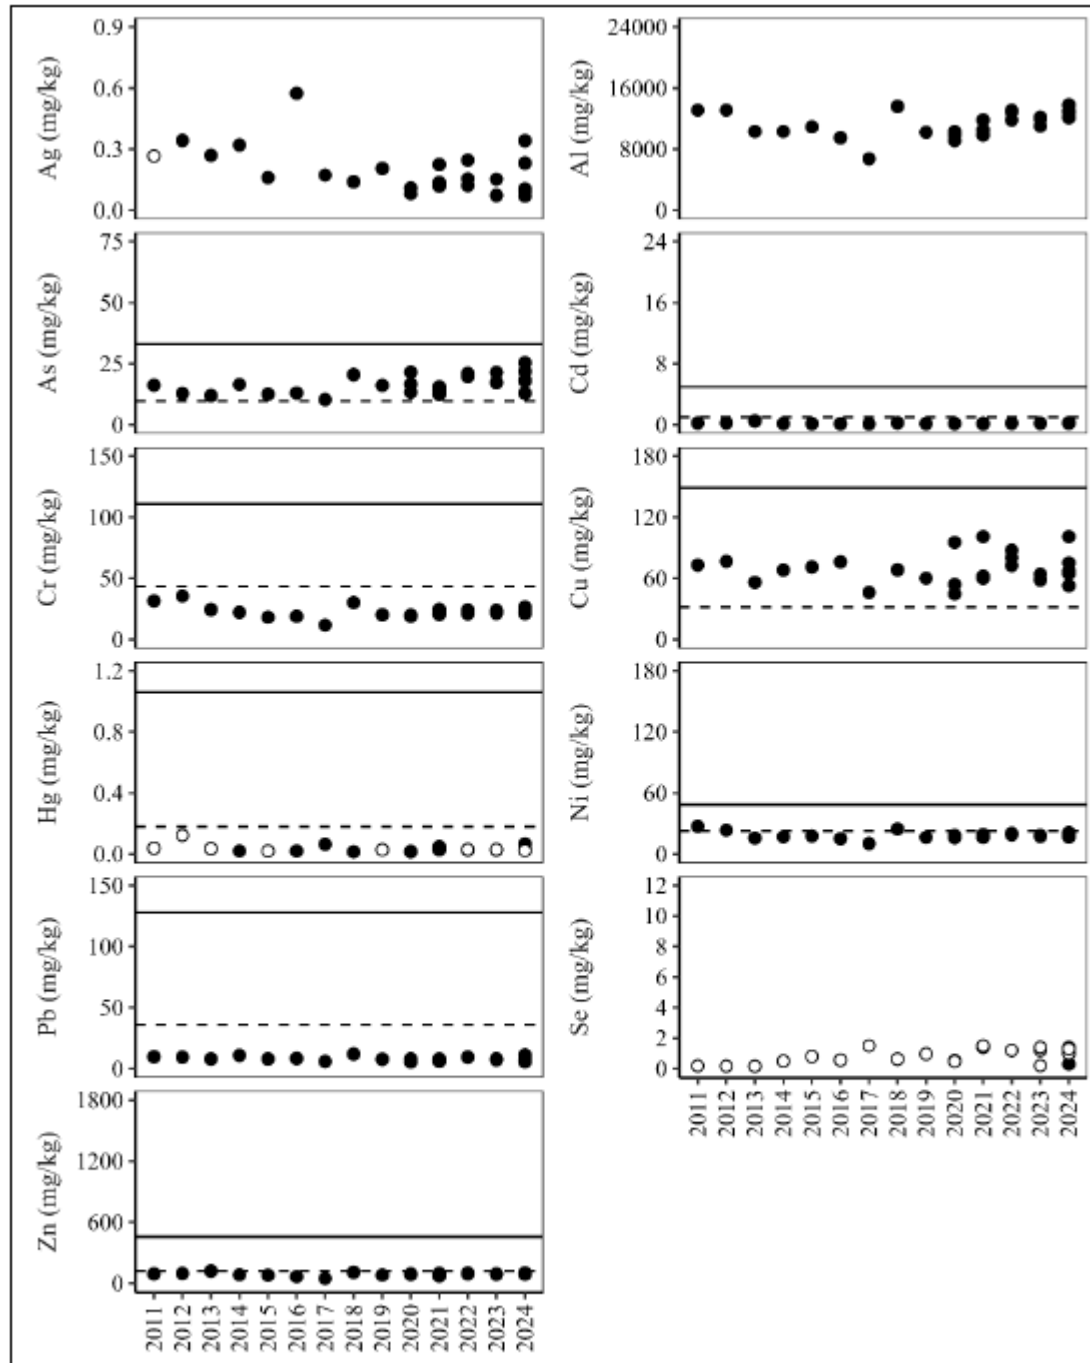
**Figure 6. Sediment sampling results compared with historic values – 2024 results represent post spill.**

Sediment samples were analyzed for aluminum, arsenic, cadmium, chromium, copper, lead, mercury, nickel, selenium, silver and zinc. LJC results were compared to historic Johnson Creek sediment metal concentrations from the same sample location dating to 2011. When compared to historic concentrations the results show no marked difference, as shown in Figure 6.

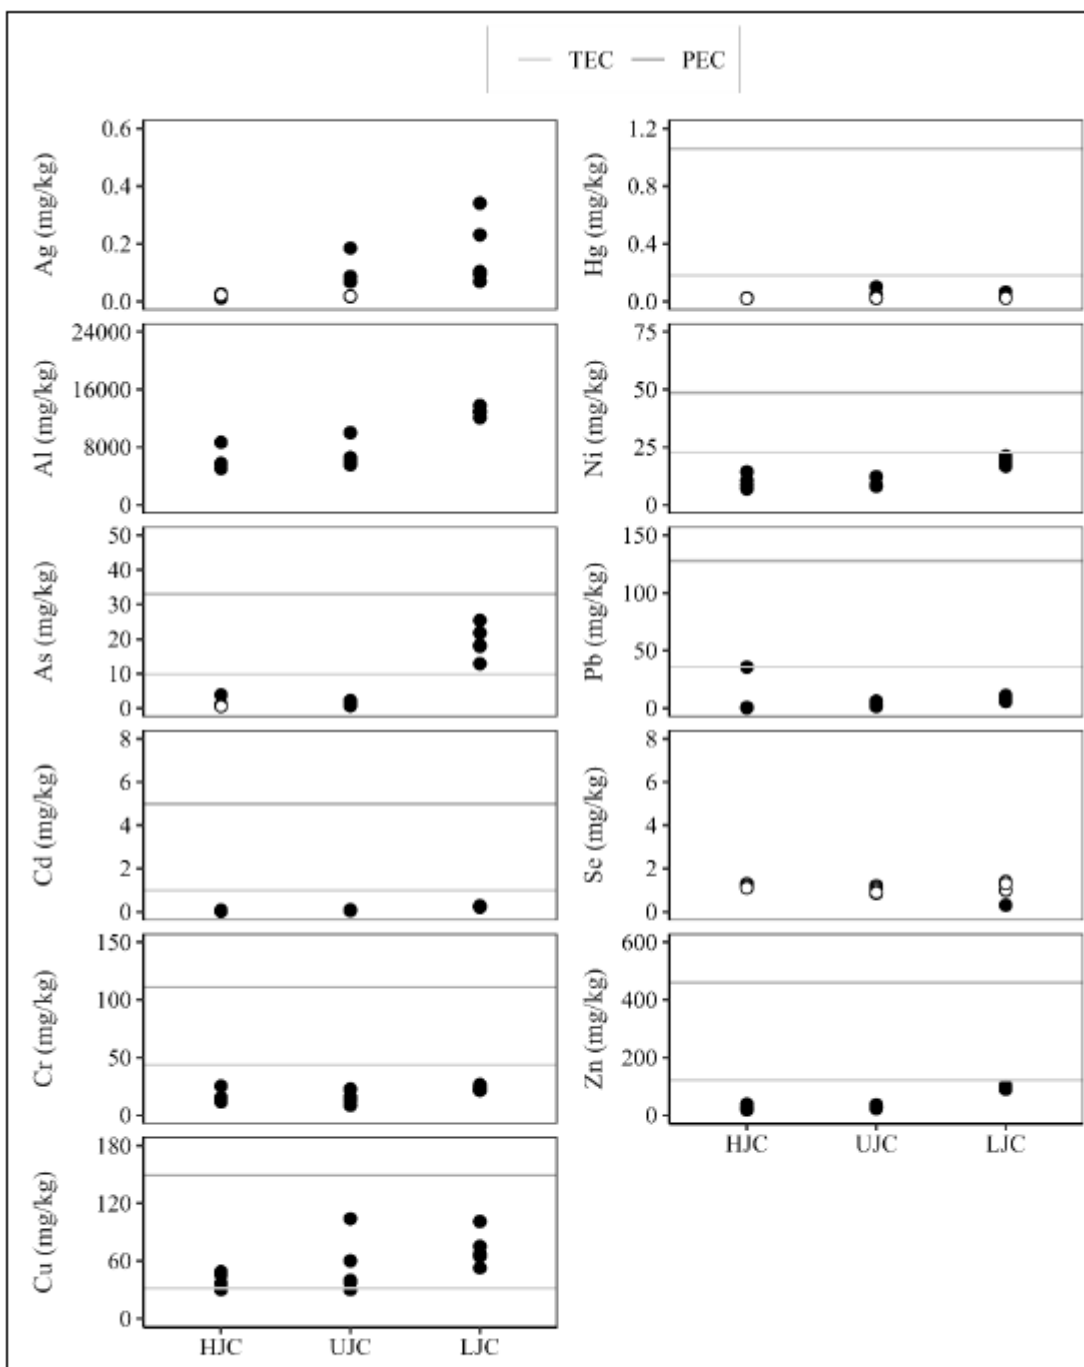
**Figure 7. Sediment sampling results compared with the TEC guidelines.**

Additionally, all sample results from the February 6<sup>th</sup> sampling were compared to the Threshold Effect Concentrations (TEC) guidelines. TEC is a concentration below which adverse effects are not expected to occur. All results remained below the TEC level, as shown in Figure 7. The sediment sampling locations can be found in Figure 8.

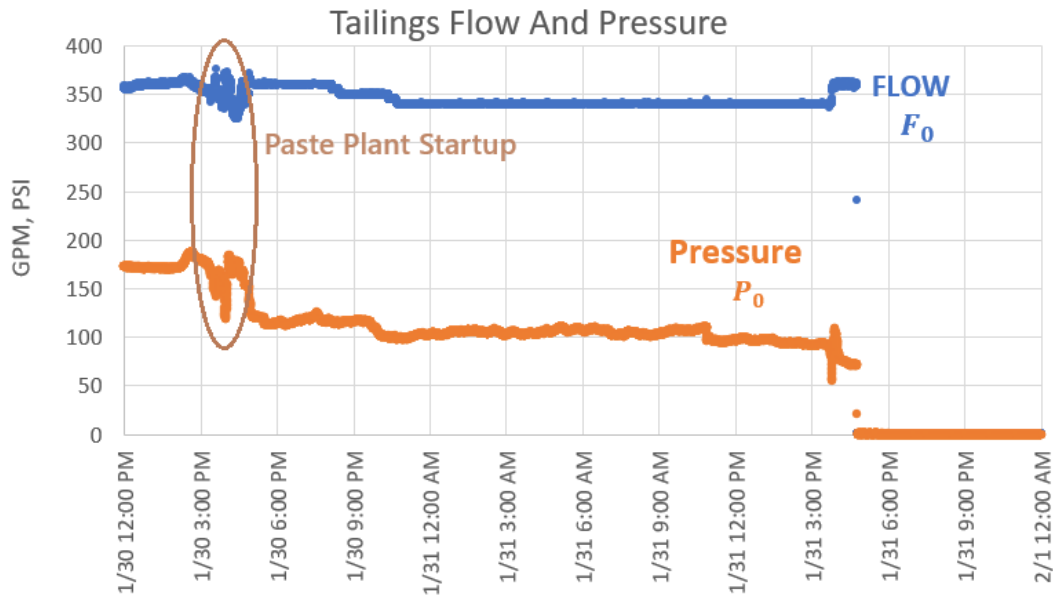
### Normal Process Change

The next event corresponds to a typical change in mill conditions. During this time, mill tonnage changed and the paste plant was started up at 4:40 pm.

Coming out of the process change, the tails line pressure is unusually low. These pressures are possible with a normal line, but only under extremely low % solids. To be conservative, the leak time was estimated to start after 5 pm on January 30<sup>th</sup>. The mill shut down before 5pm on January 31<sup>st</sup> after the leak was detected.

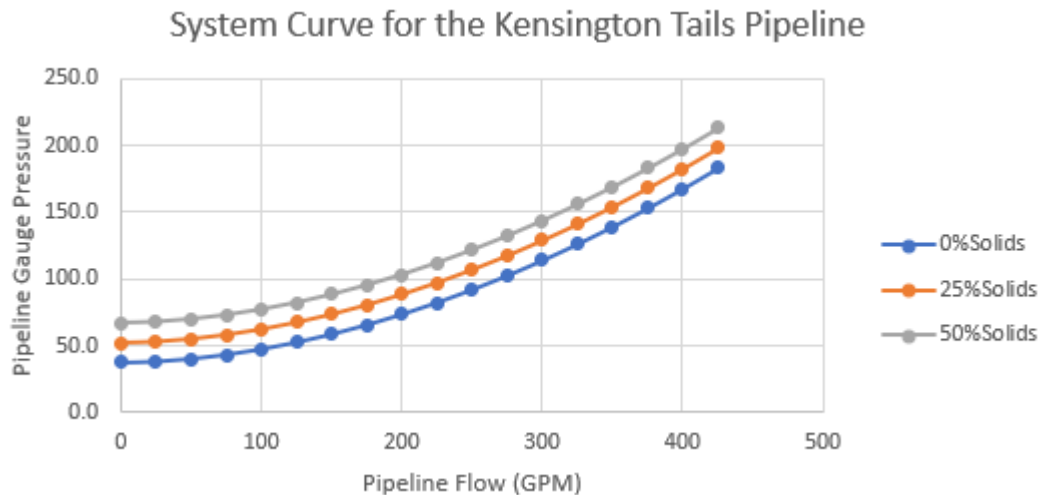
*Kensington Tails Pipeline Theoretical Pressure Vs. Flow curve for various tails slurry densities*

For a given pipeline geometry, fluid type, a given pressure will correspond to a certain flow.

Pipe pressure is a function of the system elevation gain, system pressure due to fluid friction, and system pressure due to velocity at discharge.

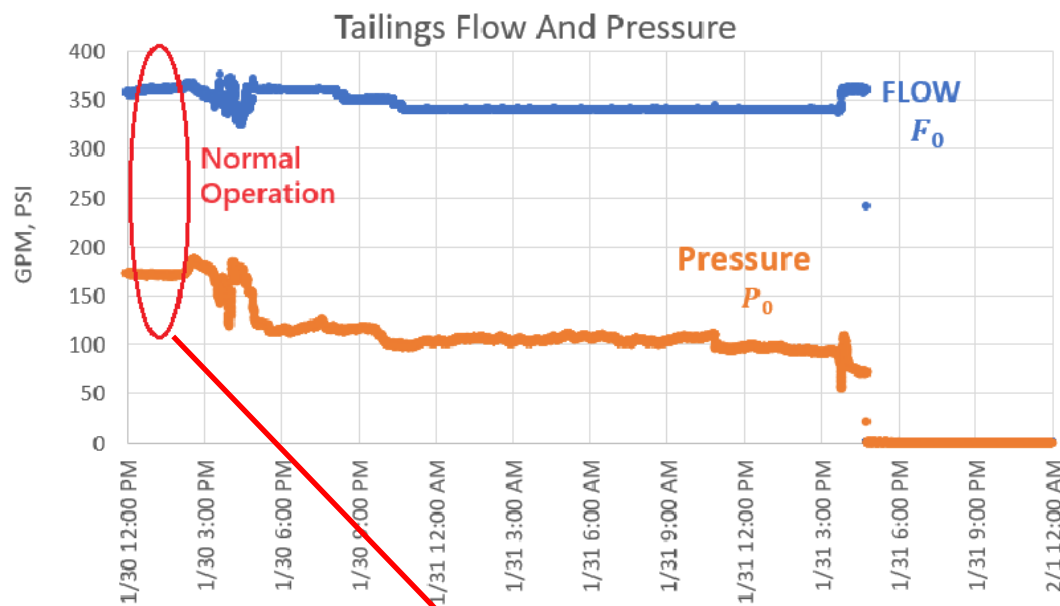
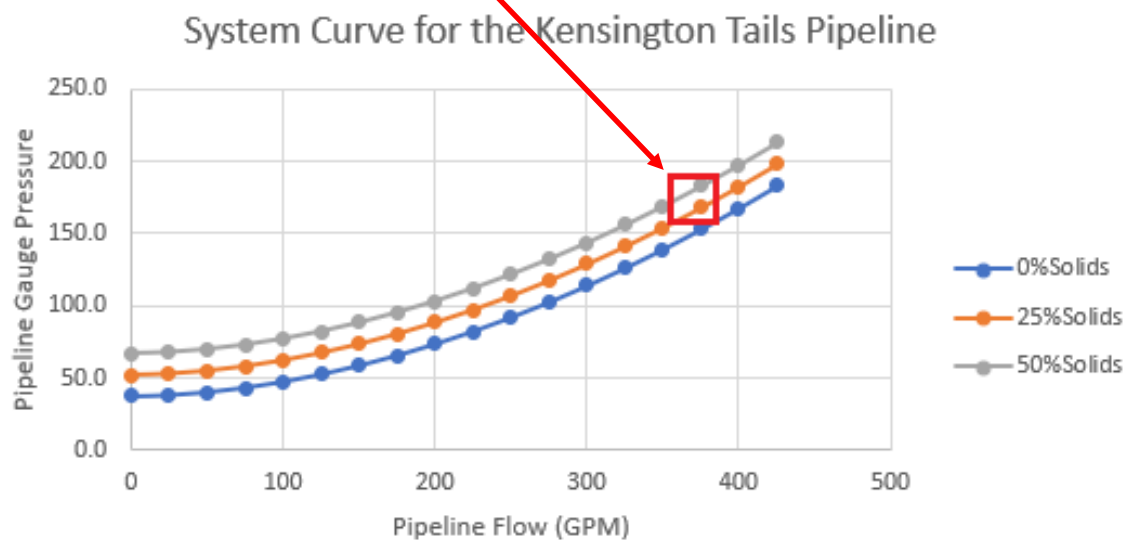
Before 3pm January 30<sup>th</sup>, the indicated pressure of 170 PSI corresponds to a Flow of 360-365 GPM. This reasonably matches the system curve for a 25-50% solids slurry, typical for a No Paste Plant Operation

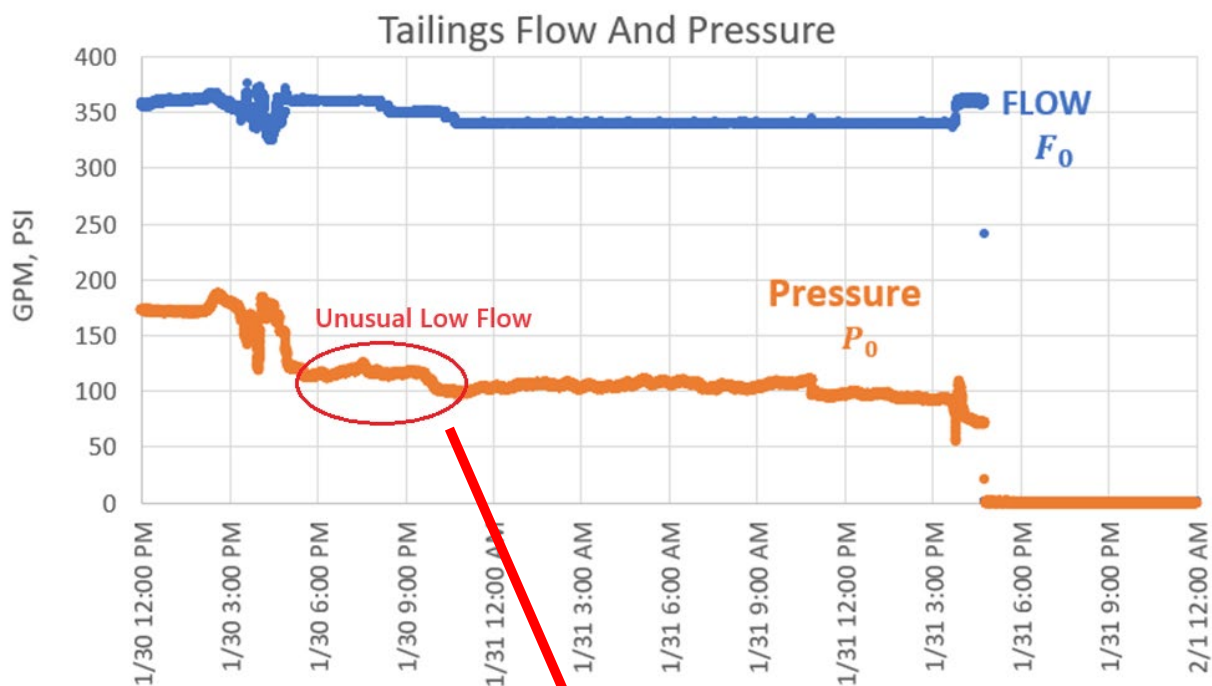
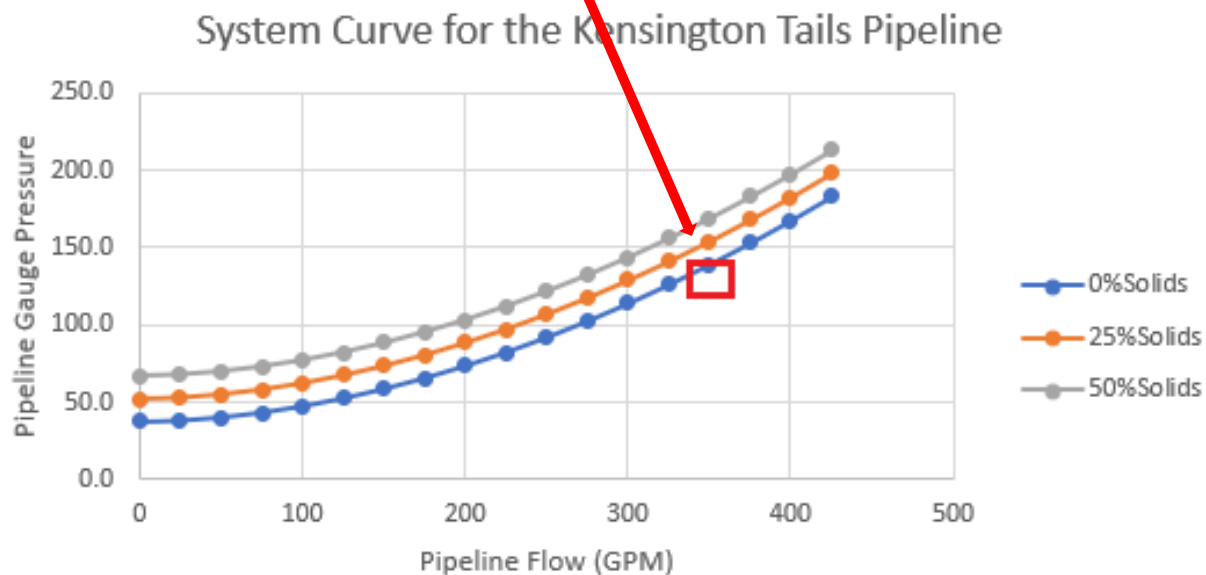
After 5pm, we are now operating at very different pressure and flow parameters.

While it is not impossible to be running under 15% solids in the tails slurry after a paste startup, it is unlikely. 5 PM was tagged as the likely start time of the event.

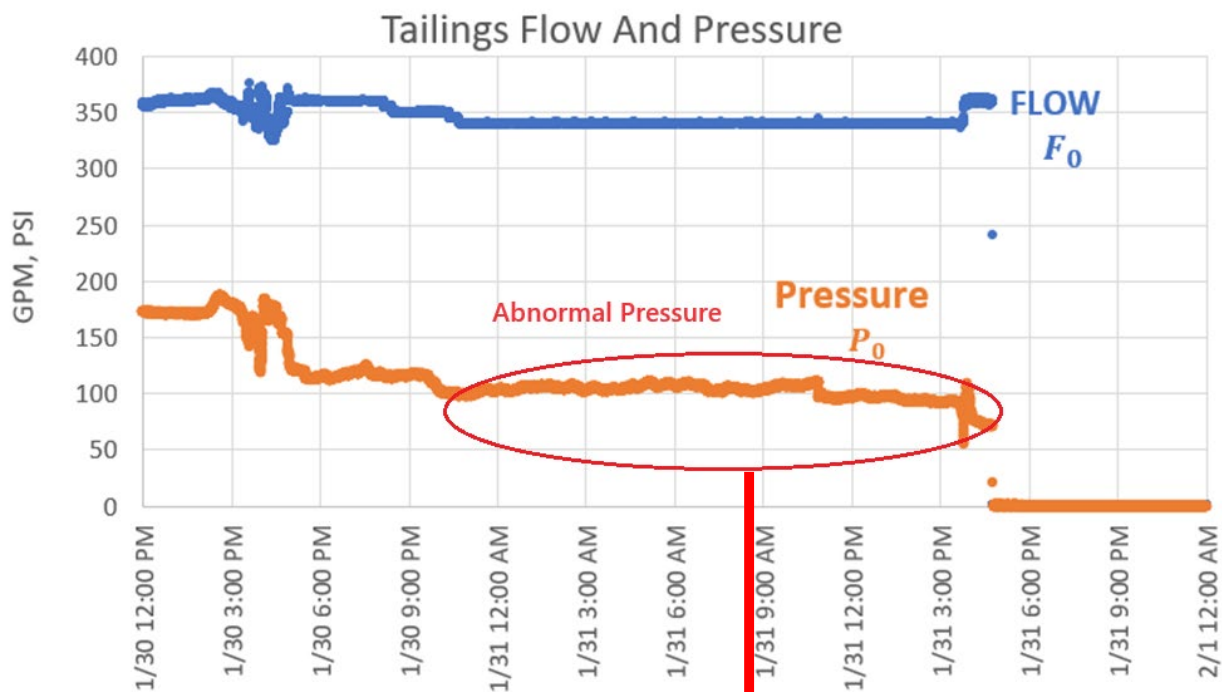
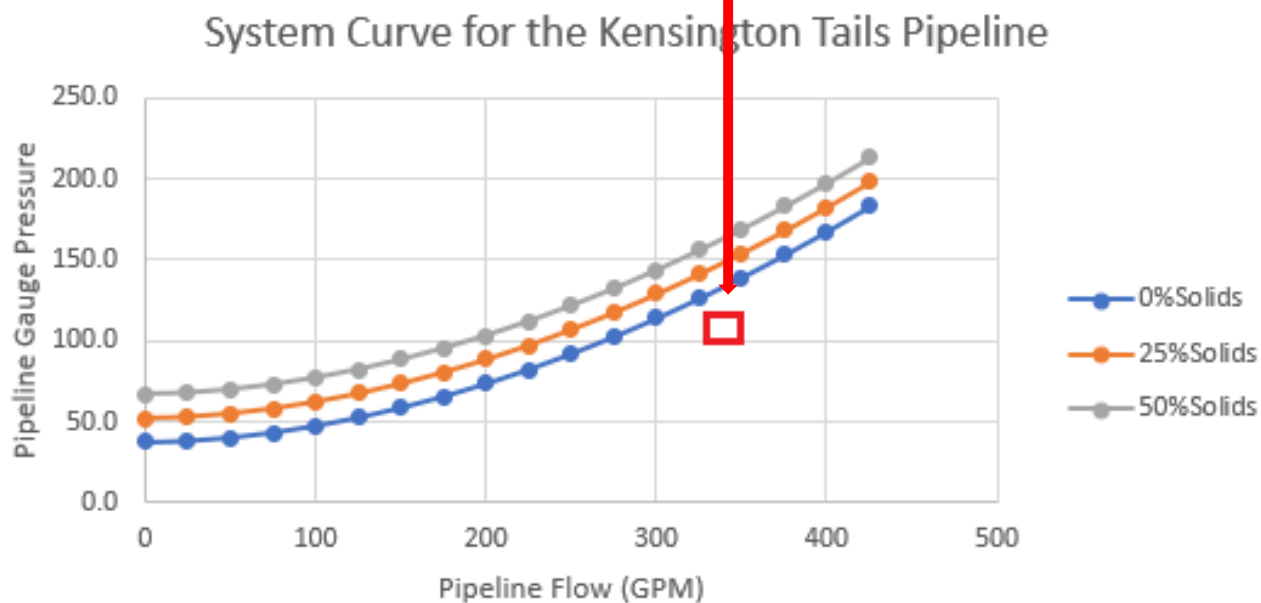
After 10 PM, our pressure readings indicate we are no longer operating with the same “System Curve” or the same pipeline.

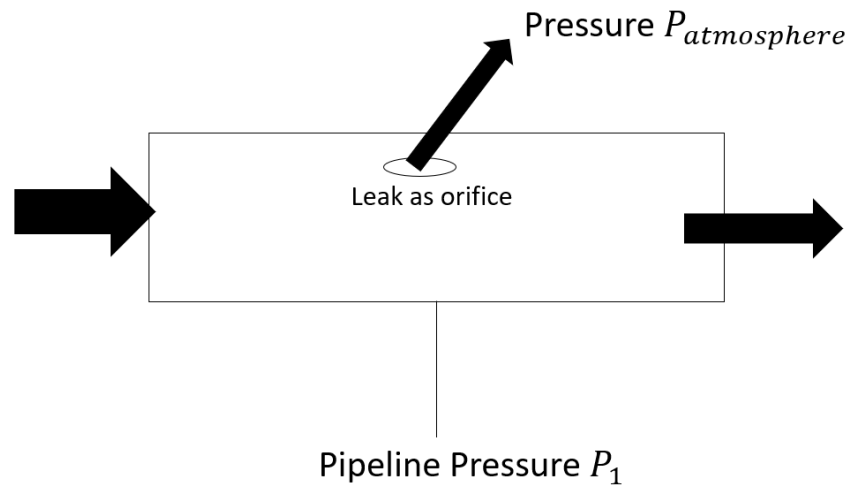
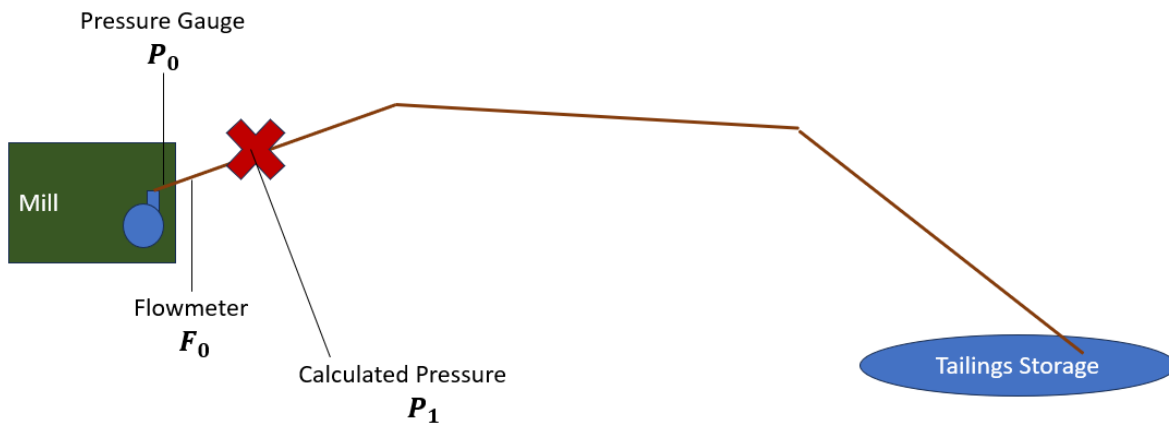
After shutdown of the pipeline, a hole leaking tails was found to be about 1.5 inches long and 5/8<sup>th</sup> inches wide. This hole was modeled as a perpendicular orifice with no pressure drop.

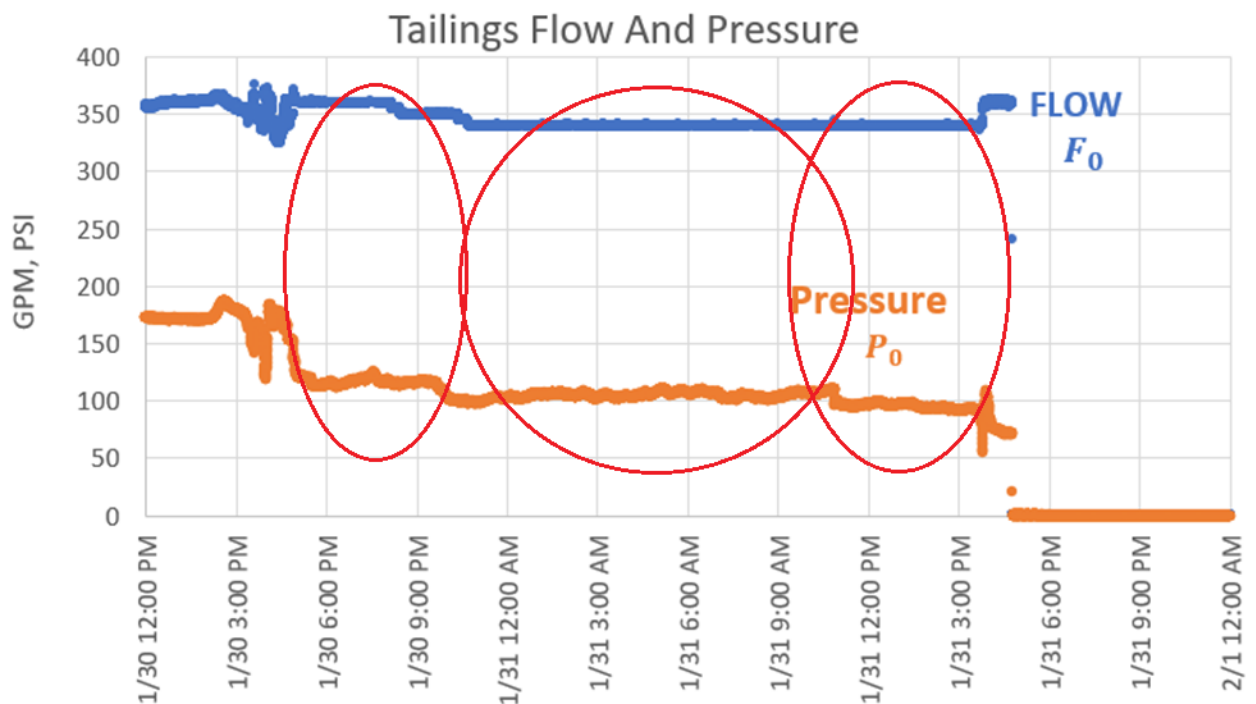
$P_0$	$F_0$	$P_1$
Indicated Pressure	Indicated Flow	Calculated Orifice Pressure
PSI	GPM	PSI
120	360	80.3
104	340	64.8
95	340	55.8

These 3 pressure and flow combinations correspond to these three time frames.
